Uniform Mitigation Verification Inspection Form

Inspection Date: 09-13-2024					
Owner Information					
Owner Name: Vista III at Heritage Bay Condominium Association, Inc. Contact Person:					
Address: 9047 Gervais Circle	Home Phone:				
City: Naples	Zip: 34120	Work Phone:			
County: Collier		Cell Phone:			
Insurance Company:	Policy #:				
Year of Home: Completed in 2008	# of Stories: 2	Email:

Vista III at Heritage Bay Condominium Association, Inc. 9047 Gervais Circle, Naples, FL 34120 09-13-2024

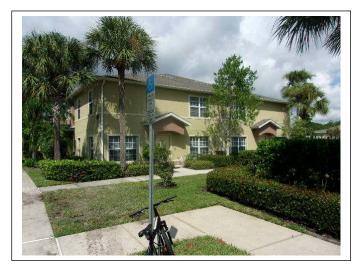
SIDE ELEVATION VIEW – The side entryway gables are not structurally connected to the main roofing system. They are attached to the reinforced walls.

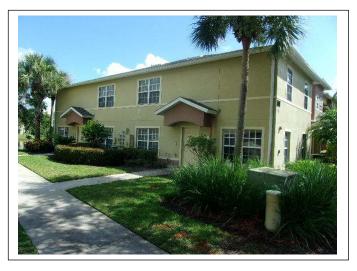
SIDE ELEVATION VIEW – The side entryway gables are not structurally connected to the main roofing system. They are attached to the reinforced walls.

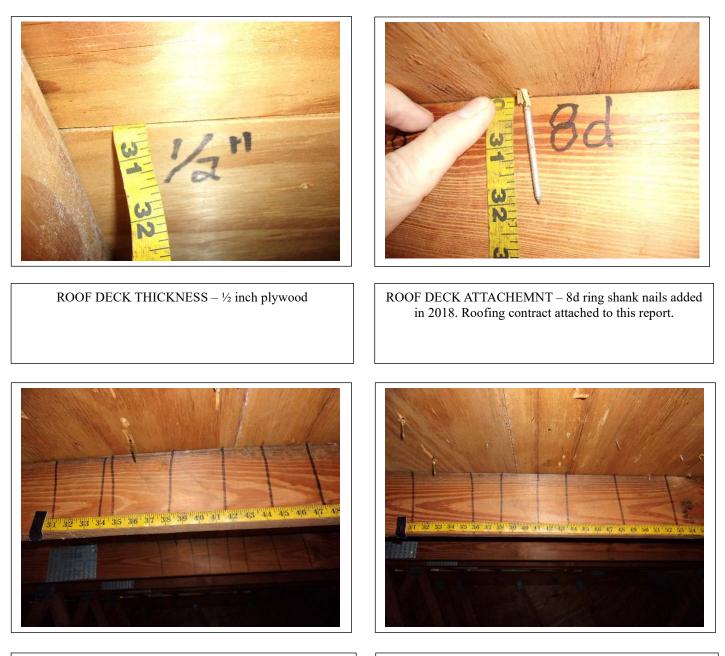
ROOF DECK ATTACHMENT – 8d nails within 6 inches along the edge

ROOF DECK ATTACHMENT – 8d nails within 6 inches in the field

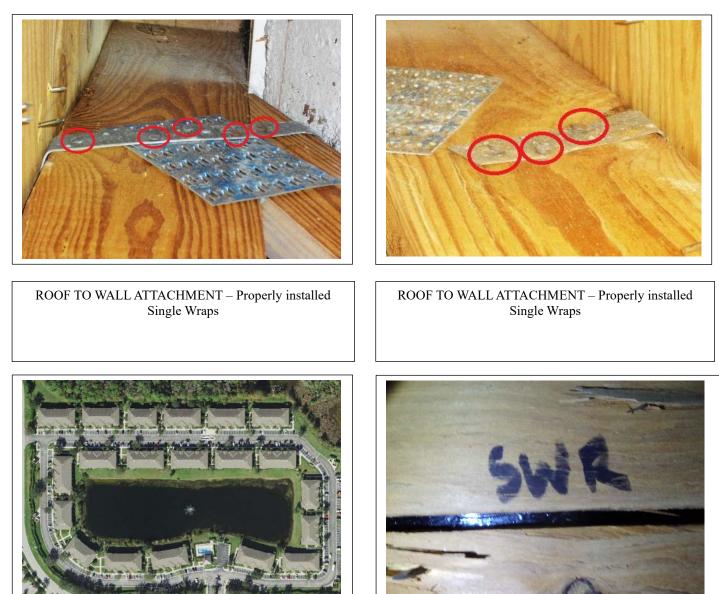
ROOF GEOMETRY – Aerial view of the Hip Roof Shape.

SECONDARY WATER BARRIER – A polymer adhesive (peel & stick) SWR Barrier was installed on the entire roof deck in 2018. Documentation attached to this report. NOA#15-0707.09

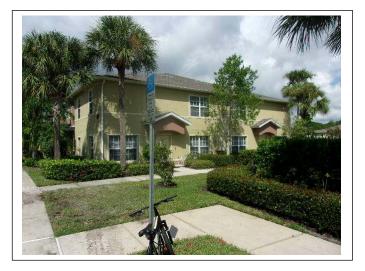
OPENING PROTECTION – The hinged entry doors cannot be identified as being impact rated, but local and FBC required the doors to be ASTM E-330 rated at a minimum.

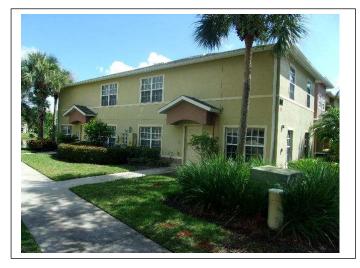
OPENING PROTECTION – The hinged entry doors cannot be identified as being impact rated, but local and FBC required the doors to be ASTM E-330 rated at a minimum.

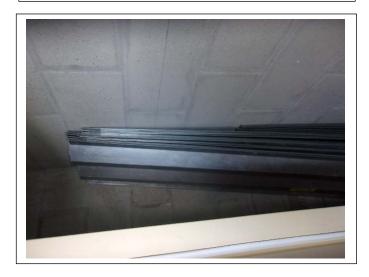
OPENING PROTECTION – Per local code and the FBC, large missile rated metal corrugated shutter panels are available to protect all glazed openings. FBC# FL11964.1

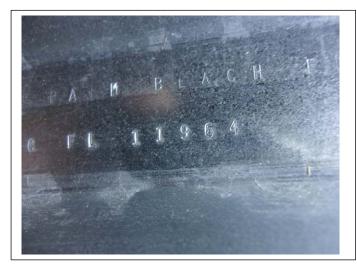
OPENING PROTECTION – The metal corrugated shutter panel's product approval stamp. FBC# FL11964.1

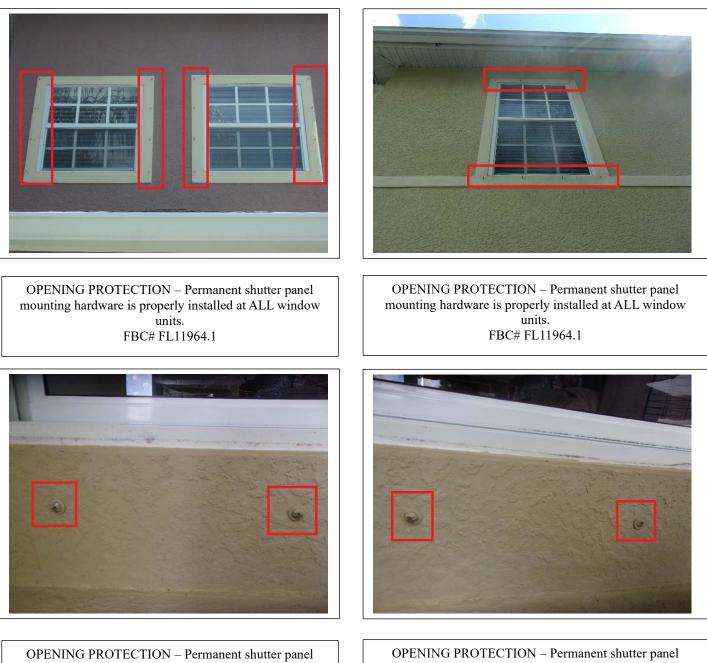
OPENING PROTECTION – Permanent shutter panel mounting hardware is properly installed at ALL window units. FBC# FL11964.1 OPENING PROTECTION – Permanent shutter panel mounting hardware is properly installed at ALL window units. FBC# FL11964.1

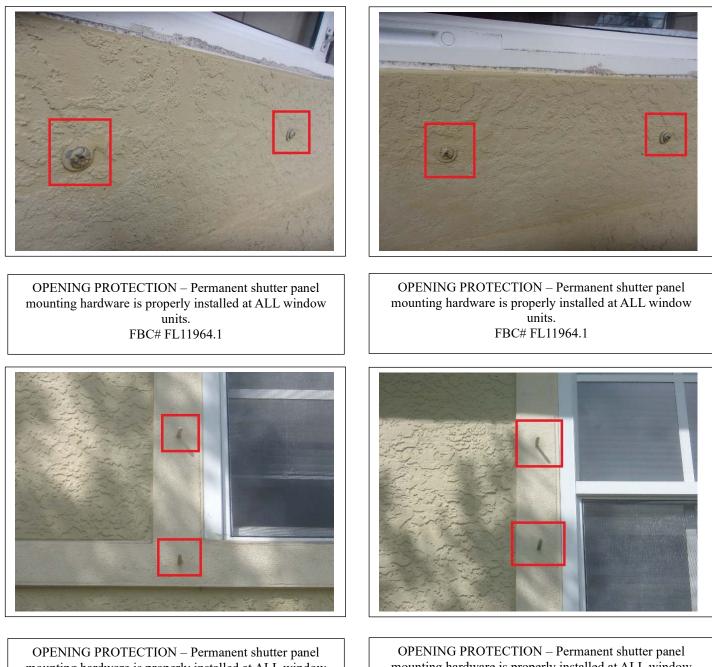
OPENING PROTECTION – Permanent shutter panel mounting hardware is properly installed at ALL window units. FBC# FL11964.1 OPENING PROTECTION – Permanent shutter panel mounting hardware is properly installed at ALL window units. FBC# FL11964.1

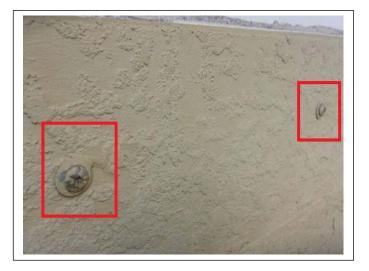
OPENING PROTECTION – Permanent shutter panel mounting hardware is properly installed at ALL sliding glass door units. FBC# FL11964.1

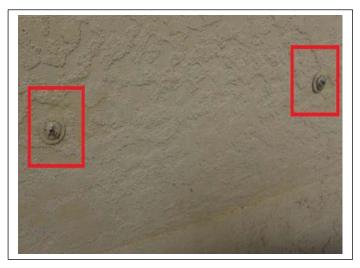
OPENING PROTECTION – Permanent shutter panel mounting hardware is properly installed at ALL sliding glass door units. FBC# FL11964.1
