## **Uniform Mitigation Verification Inspection Form**

Inspection Date: 09-13-2024		
Owner Information		
Owner Name: Vista III at Heritage Bay	Condominium Association, Inc.	Contact Person:
Address: 9051 Gervais Circle		Home Phone:
City: Naples	Zip: <b>34120</b>	Work Phone:
County: Collier		Cell Phone:
Insurance Company:		Policy #:
Year of Home: Completed in 2008	# of Stories: 2	Email:

Qualified Inspector Name:	License Type:	License or Certificate #:
Richard Verblaauw	Certified General Contractor	CGC1505916
Inspection Company: R3 of Florida, LLC	Phone: 2	39.810.7793

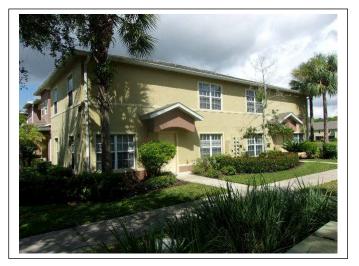
SIDE ELEVATION VIEW – The side entryway gables are not structurally connected to the main roofing system. They are attached to the reinforced walls.

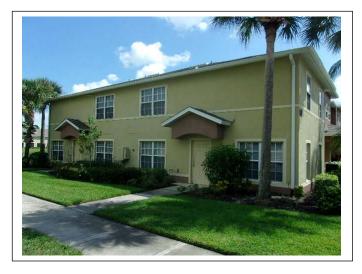
SIDE ELEVATION VIEW – The side entryway gables are not structurally connected to the main roofing system. They are attached to the reinforced walls.

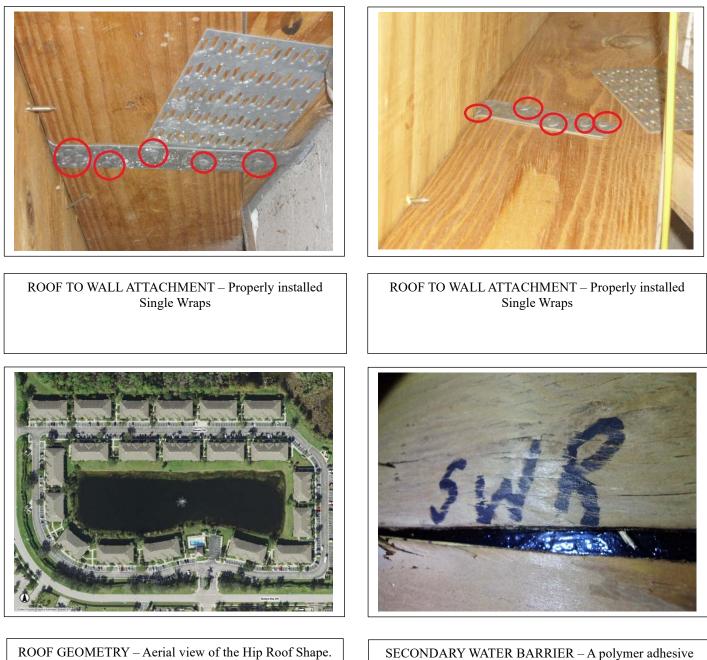
SECONDARY WATER BARRIER – A polymer adhesive (peel & stick) SWR Barrier was installed on the entire roof deck in 2018. Documentation attached to this report. NOA#15-0707.09

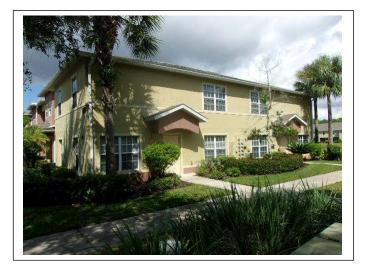
OPENING PROTECTION – The hinged entry doors cannot be identified as being impact rated, but local and FBC required the doors to be ASTM E-330 rated at a minimum.

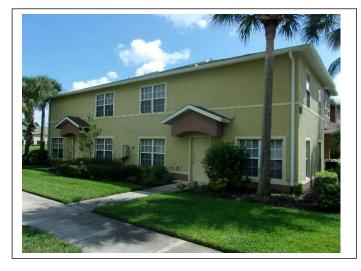
OPENING PROTECTION – The hinged entry doors cannot be identified as being impact rated, but local and FBC required the doors to be ASTM E-330 rated at a minimum.

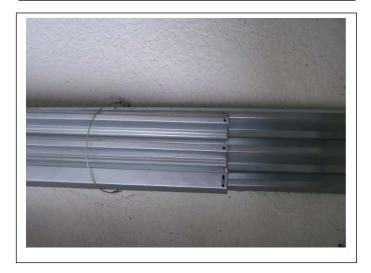
OPENING PROTECTION – Per local code and the FBC, large missile rated metal corrugated shutter panels are available to protect all glazed openings. FBC# FL11964.1

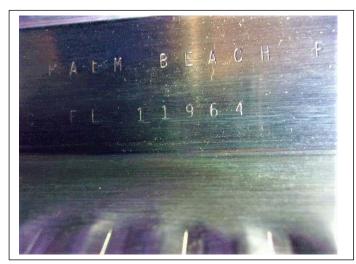
OPENING PROTECTION – The metal corrugated shutter panel's product approval stamp. FBC# FL11964.1

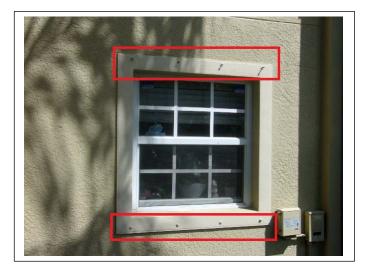
OPENING PROTECTION – Permanent shutter panel mounting hardware is properly installed at ALL window units. FBC# FL11964.1

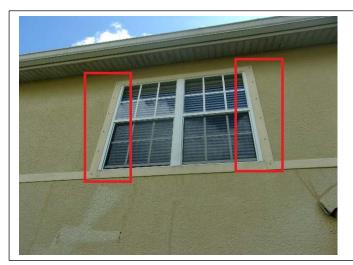
OPENING PROTECTION – Permanent shutter panel mounting hardware is properly installed at ALL window units. FBC# FL11964.1

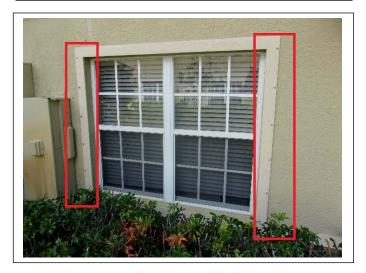
OPENING PROTECTION – Permanent shutter panel mounting hardware is properly installed at ALL window units. FBC# FL11964.1

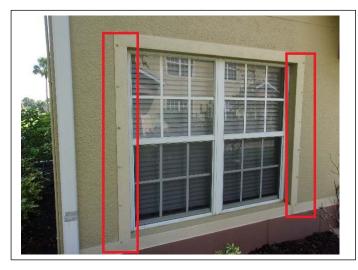
OPENING PROTECTION – Permanent shutter panel mounting hardware is properly installed at ALL window units. FBC# FL11964.1

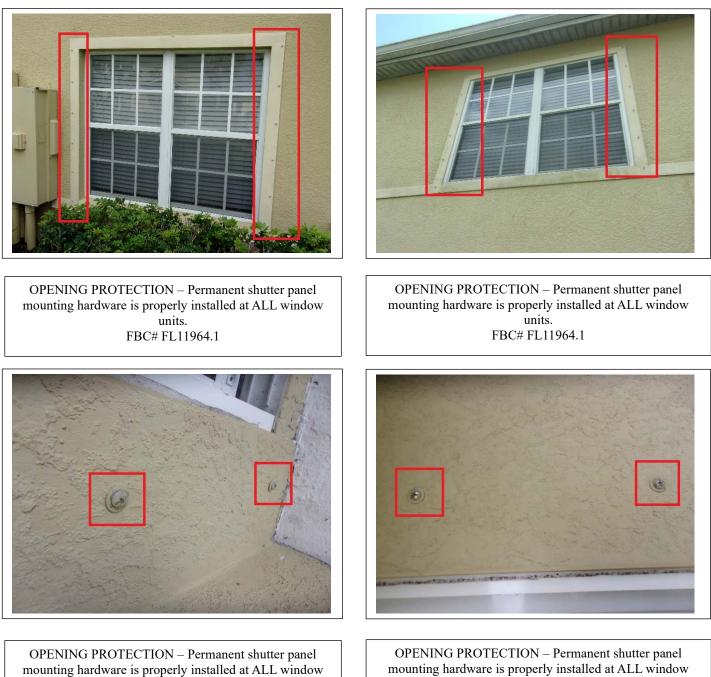
OPENING PROTECTION – Permanent shutter panel mounting hardware is properly installed at ALL window units. FBC# FL11964.1

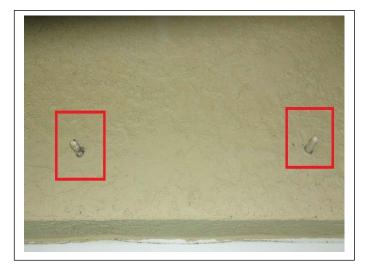
OPENING PROTECTION – Permanent shutter panel mounting hardware is properly installed at ALL sliding glass door units. FBC# FL11964.1

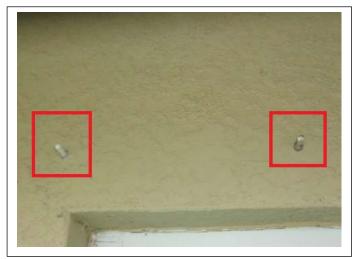
OPENING PROTECTION – Permanent shutter panel mounting hardware is properly installed at ALL sliding glass door units. FBC# FL11964.1
