Uniform Mitigation Verification Inspection Form

Inspection Date: 09-13-2024	-								
Owner Information									
Owner Name: Vista III at Heritage Bay Con	dominium Association, Inc.	Contact Person:							
Address: 9059 Gervais Circle		Home Phone:							
City: Naples	Zip: <b>34120</b>	Work Phone:							
County: Collier		Cell Phone:							
Insurance Company: Policy #:									
Year of Home: Completed in 2008 # of Stories: 2 Email:									
accompany this form. At least one photog though 7. The insurer may ask additional	ating the compliance or existence of each co graph must accompany this form to validate questions regarding the mitigated feature(	e each attribute marked s) verified on this form.	in questions 3						
the HVHZ (Miami-Dade or Broward could A. Built in compliance with the FBC a date after 3/1/2002: Building Perm □ B. For the HVHZ Only: Built in comprovide a permit application with a different provide a permit application.	provide a permit application with a date after 9/1/1994: Building Permit Application Date (MM/DD/YYYY)//

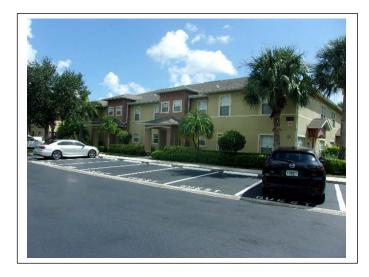
FRONT ELEVATION VIEW

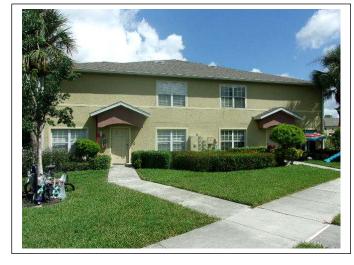
SIDE ELEVATION VIEW – The side entryway gables are not structurally connected to the main roofing system.

They are attached to the reinforced walls.

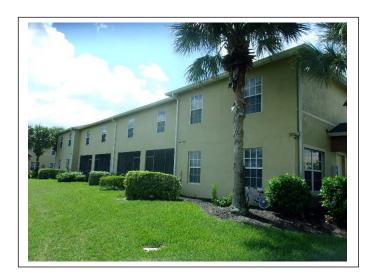
REAR ELEVATION VIEW

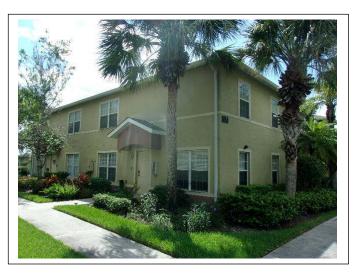
SIDE ELEVATION VIEW – The side entryway gables are not structurally connected to the main roofing system. They are attached to the reinforced walls.

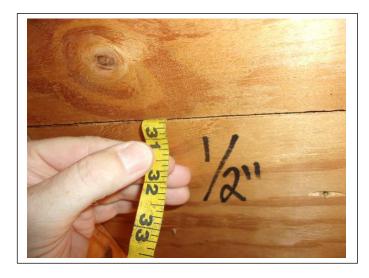
ROOF DECK THICKNESS - ½ inch plywood

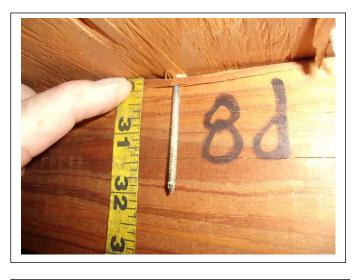
ROOF DECK ATTACHEMNT – 8d ring shank nails added in 2018. Roofing contract attached to this report.

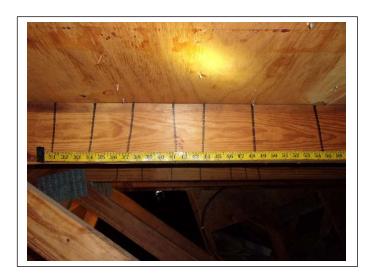
ROOF DECK ATTACHMENT – 8d nails within 6 inches along the edge

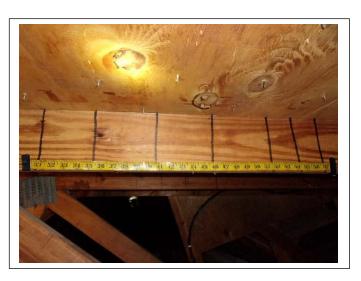
ROOF DECK ATTACHMENT – 8d nails within 6 inches in the field

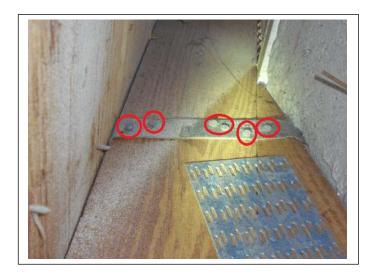
ROOF TO WALL ATTACHMENT – Properly installed Single Wraps

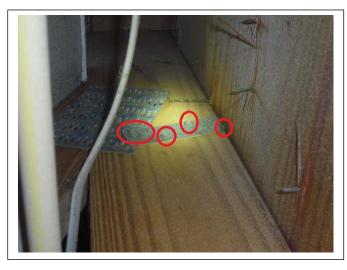
ROOF TO WALL ATTACHMENT – Properly installed Single Wraps

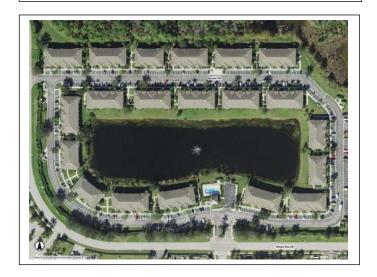
ROOF GEOMETRY – Aerial view of the Hip Roof Shape.

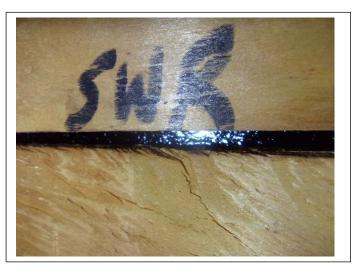
SECONDARY WATER BARRIER – A polymer adhesive (peel & stick) SWR Barrier was installed on the entire roof deck in 2018. Documentation attached to this report.

NOA#15-0707.09

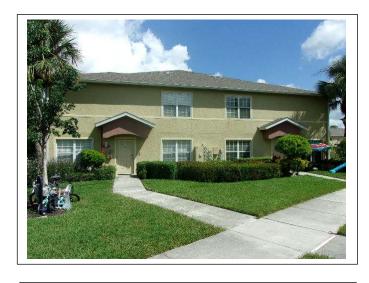
OPENING PROTECTION – The hinged entry doors cannot be identified as being impact rated, but local and FBC required the doors to be ASTM E-330 rated at a minimum.

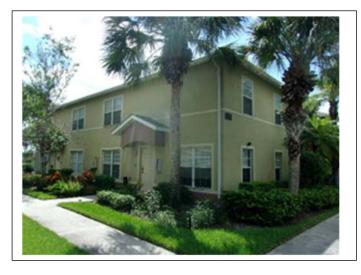
OPENING PROTECTION – The hinged entry doors cannot be identified as being impact rated, but local and FBC required the doors to be ASTM E-330 rated at a minimum.

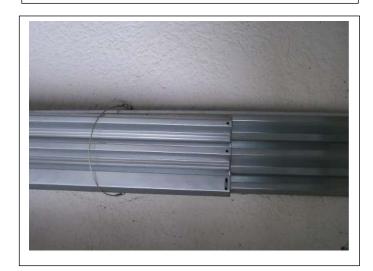
OPENING PROTECTION – Per local code and the FBC, large missile rated metal corrugated shutter panels are available to protect all glazed openings.

FBC# FL11964.1

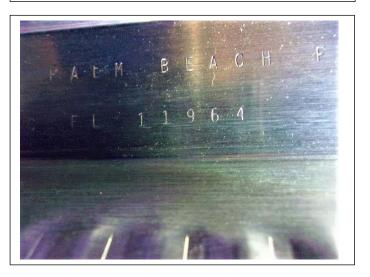
OPENING PROTECTION – The metal corrugated shutter panel's product approval stamp. FBC# FL11964.1

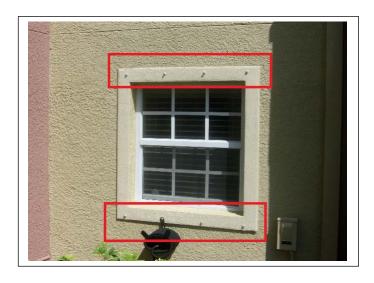
OPENING PROTECTION – Permanent shutter panel mounting hardware is properly installed at ALL window units.

FBC# FL11964.1

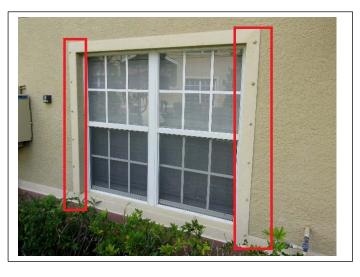
OPENING PROTECTION – Permanent shutter panel mounting hardware is properly installed at ALL window units.

FBC# FL11964.1

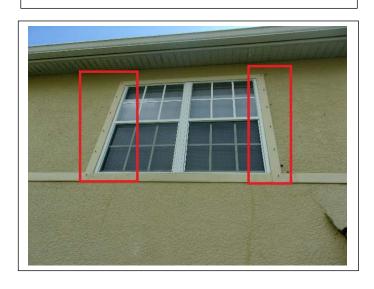
OPENING PROTECTION – Permanent shutter panel mounting hardware is properly installed at ALL window units.

FBC# FL11964.1

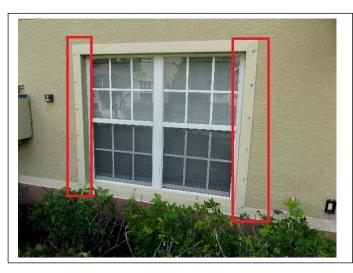
OPENING PROTECTION – Permanent shutter panel mounting hardware is properly installed at ALL window units.

FBC# FL11964.1

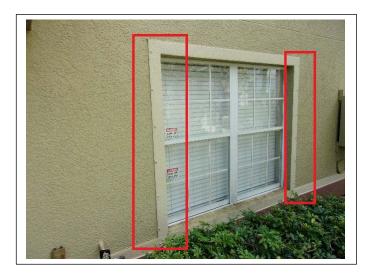
OPENING PROTECTION – Permanent shutter panel mounting hardware is properly installed at ALL window units.

FBC# FL11964.1

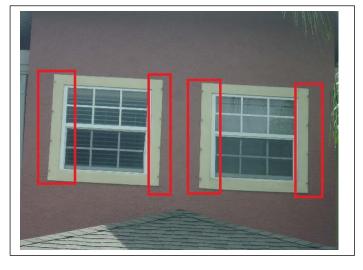
OPENING PROTECTION – Permanent shutter panel mounting hardware is properly installed at ALL window units.

FBC# FL11964.1

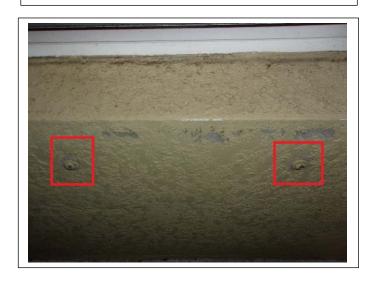
OPENING PROTECTION – Permanent shutter panel mounting hardware is properly installed at ALL window units.

FBC# FL11964.1

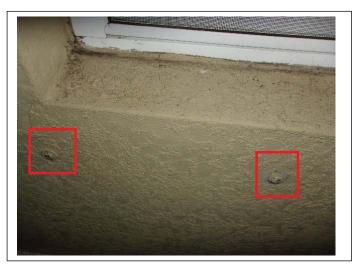
OPENING PROTECTION – Permanent shutter panel mounting hardware is properly installed at ALL window units.

FBC# FL11964.1

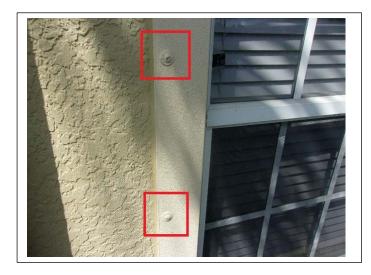
OPENING PROTECTION - Permanent shutter panel mounting hardware is properly installed at ALL window units. FBC# FL11964.1

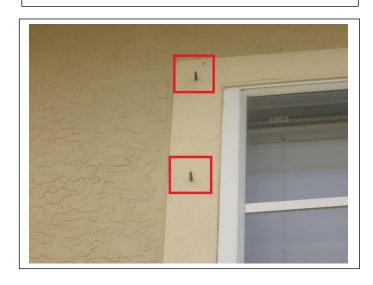
OPENING PROTECTION – Permanent shutter panel mounting hardware is properly installed at ALL window units. FBC# FL11964.1

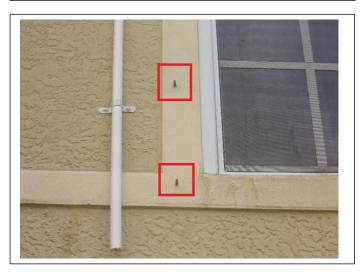
OPENING PROTECTION - Permanent shutter panel mounting hardware is properly installed at ALL window units. FBC# FL11964.1

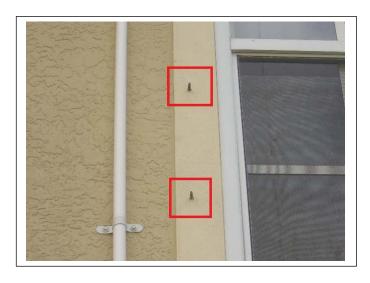
OPENING PROTECTION – The window unit's product approval. FBC# FL42.2

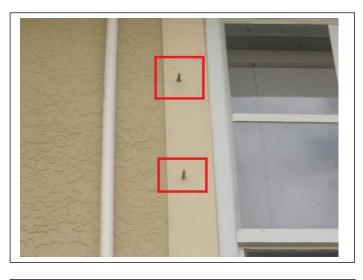
OPENING PROTECTION – The window unit's product approval.
FBC# FL42.2

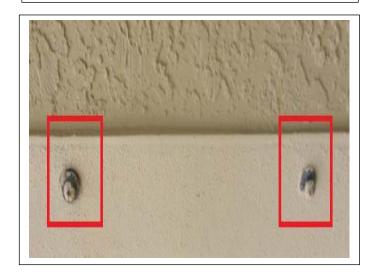
OPENING PROTECTION – Permanent shutter panel mounting hardware is properly installed at ALL sliding glass door units.

FBC# FL11964.1

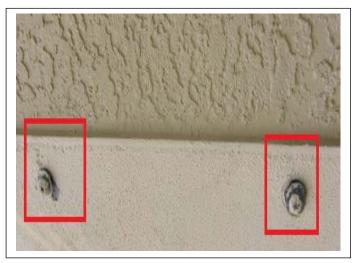
OPENING PROTECTION – Permanent shutter panel mounting hardware is properly installed at ALL sliding glass door units.

FBC# FL11964.1

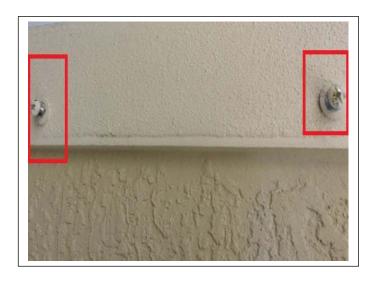
OPENING PROTECTION – Permanent shutter panel mounting hardware is properly installed at ALL sliding glass door units.
FBC# FL11964.1

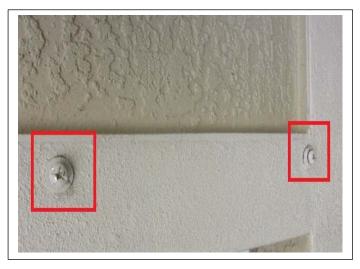
OPENING PROTECTION – Permanent shutter panel mounting hardware is properly installed at ALL sliding glass door units.

FBC# FL11964.1
