Uniform Mitigation Verification Inspection Form

Inspection Date: 09-13-2024					
Owner Information					
Owner Name: Vista III at Heritage Bay Condominium Association, Inc. Contact Person:					
Address: 9063 Gervais Circle	Home Phone:				
City: Naples Zip: 34120		Work Phone:			
County: Collier		Cell Phone:			
Insurance Company:		Policy #:			
Year of Home: Completed in 2008	# of Stories: 2	Email:

Re-Roofing Mitigation Package

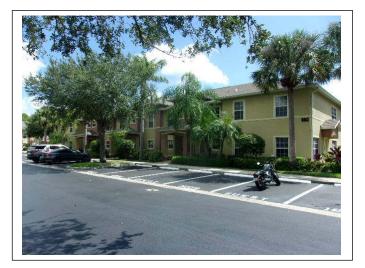
FRONT ELEVATION VIEW

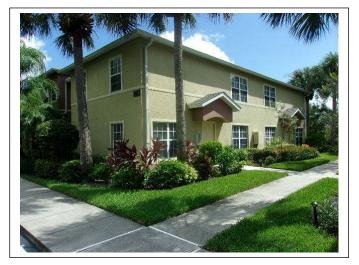
SIDE ELEVATION VIEW – The side entryway gables are not structurally connected to the main roofing system. They are attached to the reinforced walls.

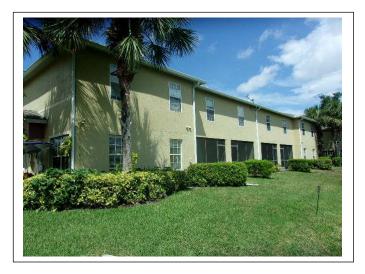
REAR ELEVATION VIEW

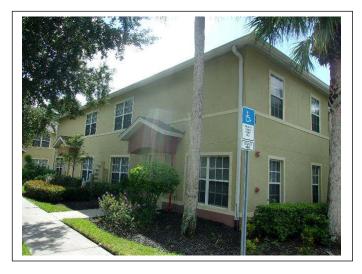
SIDE ELEVATION VIEW – The side entryway gables are not structurally connected to the main roofing system. They are attached to the reinforced walls.

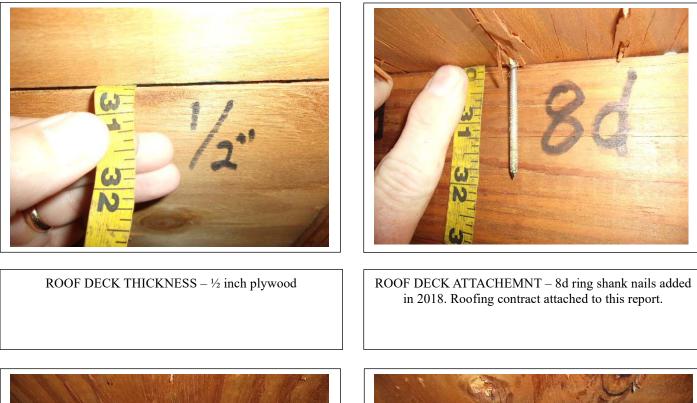
ROOF DECK ATTACHMENT – 8d nails within 6 inches along the edge

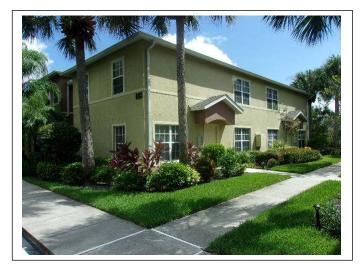
OPENING PROTECTION – The hinged entry doors cannot be identified as being impact rated, but local and FBC required the doors to be ASTM E-330 rated at a minimum.

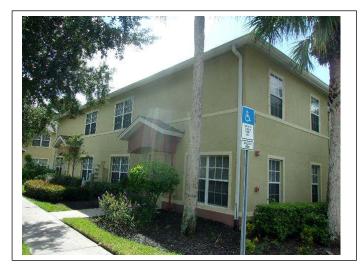
OPENING PROTECTION – The hinged entry doors cannot be identified as being impact rated, but local and FBC required the doors to be ASTM E-330 rated at a minimum.

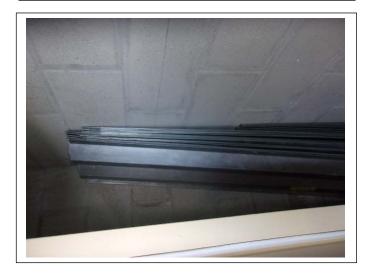
OPENING PROTECTION – Per local code and the FBC, large missile rated metal corrugated shutter panels are available to protect all glazed openings. FBC# FL11964.1

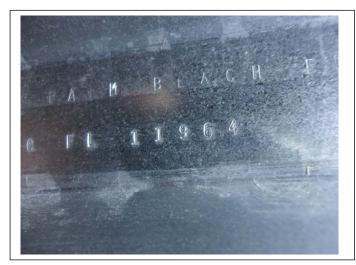
OPENING PROTECTION – The metal corrugated shutter panel's product approval stamp. FBC# FL11964.1

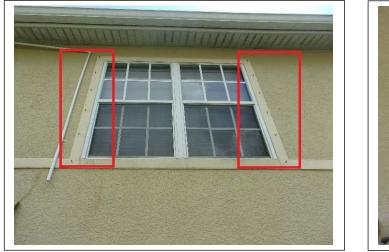
OPENING PROTECTION – Permanent shutter panel mounting hardware is properly installed at ALL window units. FBC# FL11964.1

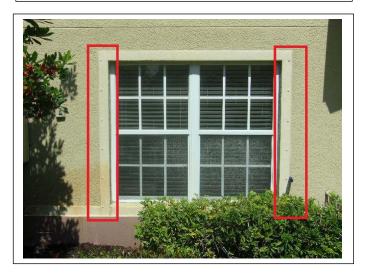
OPENING PROTECTION – Permanent shutter panel mounting hardware is properly installed at ALL window units. FBC# FL11964.1

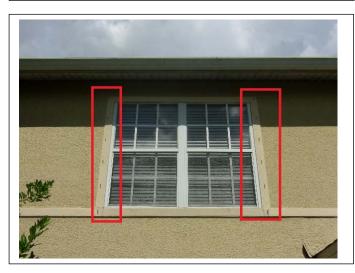
OPENING PROTECTION – Permanent shutter panel mounting hardware is properly installed at ALL window units. FBC# FL11964.1

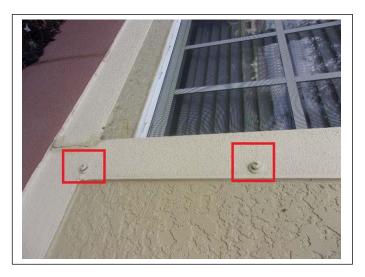
OPENING PROTECTION – Permanent shutter panel mounting hardware is properly installed at ALL window units. FBC# FL11964.1

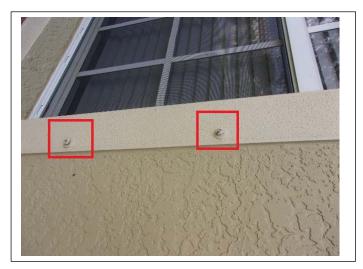
OPENING PROTECTION – Permanent shutter panel mounting hardware is properly installed at ALL window units. FBC# FL11964.1

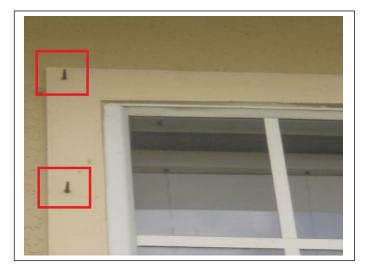
OPENING PROTECTION – Permanent shutter panel mounting hardware is properly installed at ALL window units. FBC# FL11964.1

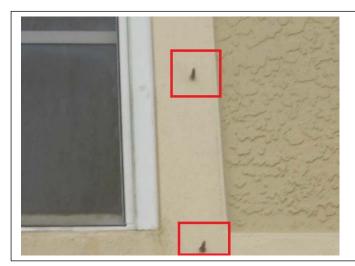
OPENING PROTECTION – Permanent shutter panel mounting hardware is properly installed at ALL window units. FBC# FL11964.1

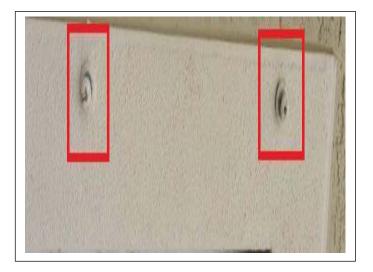
OPENING PROTECTION – Permanent shutter panel mounting hardware is properly installed at ALL sliding glass door units. FBC# FL11964.1

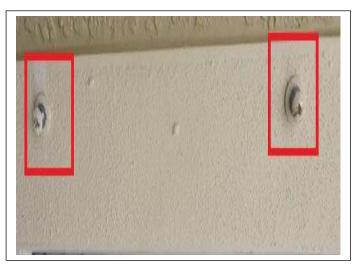
OPENING PROTECTION – Permanent shutter panel mounting hardware is properly installed at ALL sliding glass door units. FBC# FL11964.1
