Uniform Mitigation Verification Inspection Form

Inspect	ion Date: <b>09-13-2024</b>		-		
Owner	· Information				
Owner	Name: Vista Townhomes at Her	itage Bay Association,	Inc.	Contact Person:	
Addres	s: 9072 Gervais Circle			Home Phone:	
City: N		Zip: <b>34120</b>		Work Phone:	
County	Collier			Cell Phone:	
	nce Company:			Policy #:	
Year o	f Home: Completed in 2010	# of Stories: 2		Email:	
accom though	: Any documentation used in va pany this form. At least one pho 17. The insurer may ask additio	tograph must accompa nal questions regardin	nny this form to valida g the mitigated featur	te each attribute marked e(s) verified on this form	d in questions 3
the	A. Built in compliance with the F a date after 3/1/2002: Built in c B. For the HVHZ Only: Built in c provide a permit application with C. Unknown or does not meet the	counties), South Florida BC: Year Built  rmit Application Date of compliance with the SFE a date after 9/1/1994: B	Building Code (SFBC- For homes built in MM/DD/YYYY) 02/04/2010 BC-94: Year Built uilding Permit Applica	-94)? 1 2002/2003 provide a per 0 For homes built in 19	mit application with

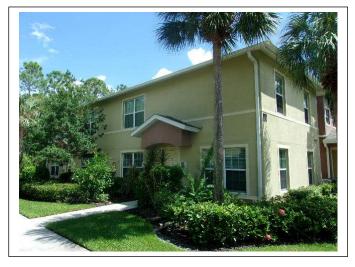
SIDE ELEVATION VIEW – The side entryway gables are not structurally connected to the main roofing system.

They are attached to the reinforced walls.

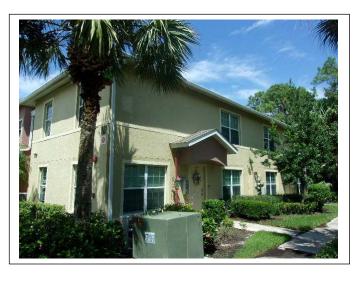
SIDE ELEVATION VIEW – The side entryway gables are not structurally connected to the main roofing system. They are attached to the reinforced walls.

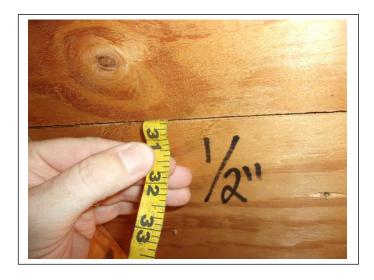
ROOF DECK THICKNESS –  $\frac{1}{2}$  inch plywood

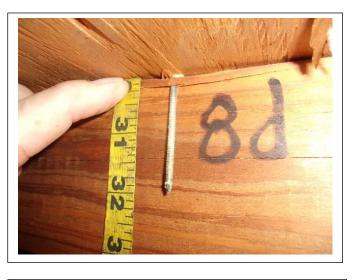
ROOF DECK ATTACHEMNT – 8d ring shank nails added in 2018. Roofing contract attached to this report.

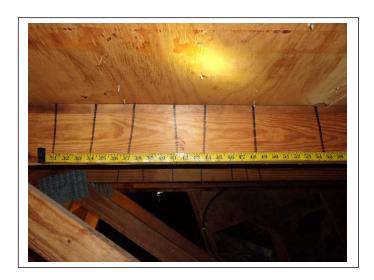
ROOF DECK ATTACHMENT – 8d nails within 6 inches along the edge  $\,$

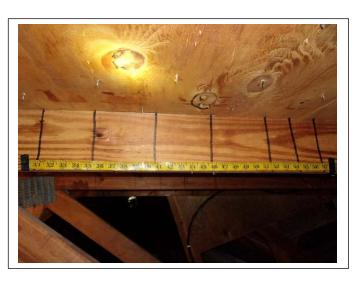
ROOF DECK ATTACHMENT – 8d nails within 6 inches in the field

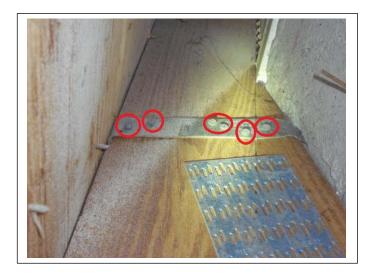
ROOF TO WALL ATTACHMENT – Properly installed Single Wraps

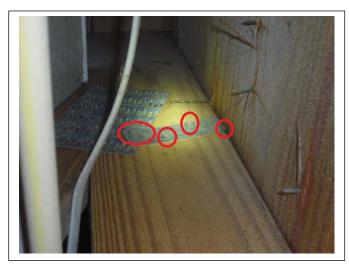
ROOF TO WALL ATTACHMENT – Properly installed Single Wraps

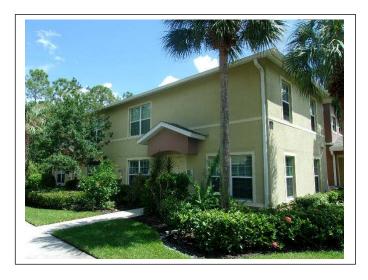
OPENING PROTECTION – The hinged entry doors cannot be identified as being impact rated, but local and FBC required the doors to be ASTM E-330 rated at a minimum.

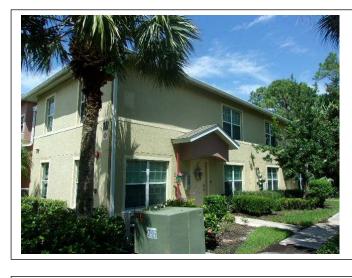
OPENING PROTECTION – The hinged entry doors cannot be identified as being impact rated, but local and FBC required the doors to be ASTM E-330 rated at a minimum.

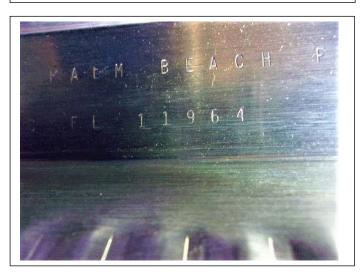
OPENING PROTECTION – The metal corrugated shutter panel's product approval stamp. FBC# FL11964.1

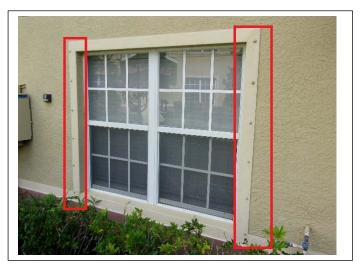
FBC# FL11964.1

OPENING PROTECTION – Permanent shutter panel mounting hardware is properly installed at ALL window units.

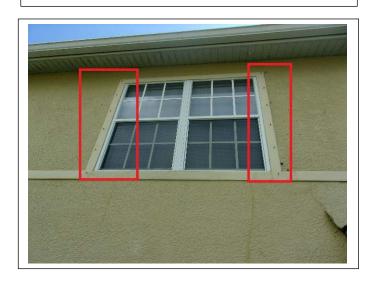
FBC# FL11964.1

OPENING PROTECTION – Permanent shutter panel mounting hardware is properly installed at ALL window units.

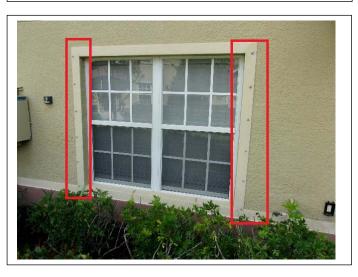
FBC# FL11964.1

OPENING PROTECTION – Permanent shutter panel mounting hardware is properly installed at ALL window units.

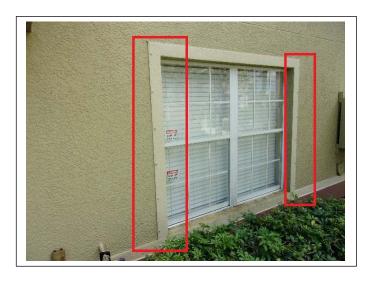
FBC# FL11964.1

OPENING PROTECTION – Permanent shutter panel mounting hardware is properly installed at ALL window units.

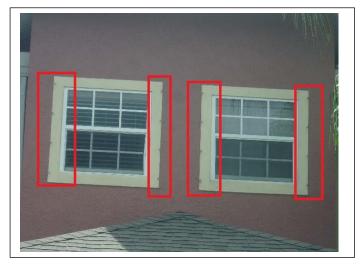
FBC# FL11964.1

OPENING PROTECTION – Permanent shutter panel mounting hardware is properly installed at ALL window units.

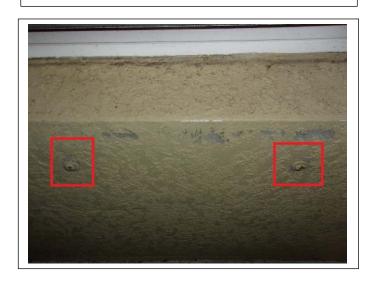
FBC# FL11964.1

OPENING PROTECTION – Permanent shutter panel mounting hardware is properly installed at ALL window units.

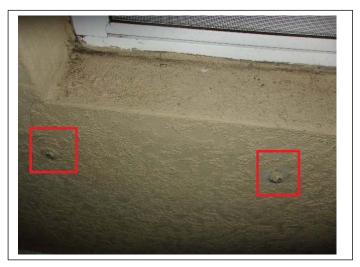
FBC# FL11964.1

OPENING PROTECTION – Permanent shutter panel mounting hardware is properly installed at ALL window units.

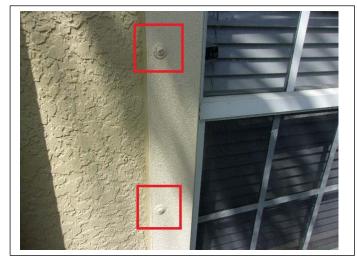
FBC# FL11964.1

OPENING PROTECTION – Permanent shutter panel mounting hardware is properly installed at ALL window units.

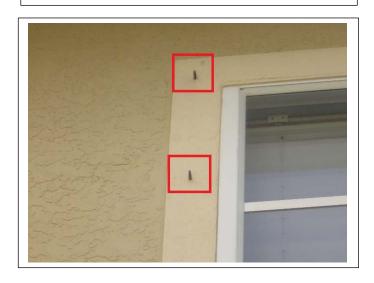
FBC# FL11964.1

OPENING PROTECTION – Permanent shutter panel mounting hardware is properly installed at ALL window units.

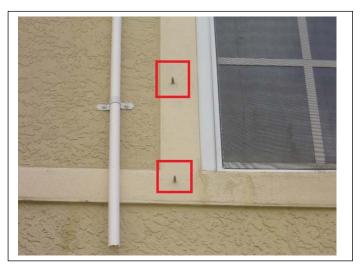
FBC# FL11964.1

OPENING PROTECTION – Permanent shutter panel mounting hardware is properly installed at ALL window units.

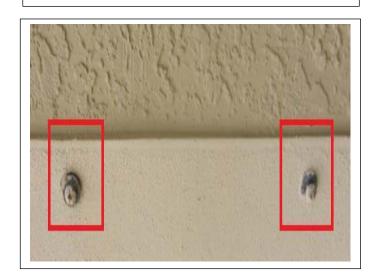
FBC# FL11964.1

OPENING PROTECTION – Permanent shutter panel mounting hardware is properly installed at ALL sliding glass door units.

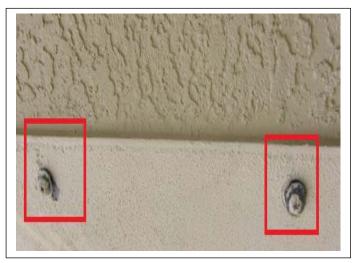
FBC# FL11964.1

OPENING PROTECTION – Permanent shutter panel mounting hardware is properly installed at ALL sliding glass door units.

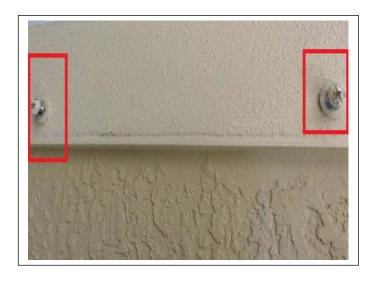
OPENING PROTECTION – Permanent shutter panel mounting hardware is properly installed at ALL sliding glass door units.
FBC# FL11964.1

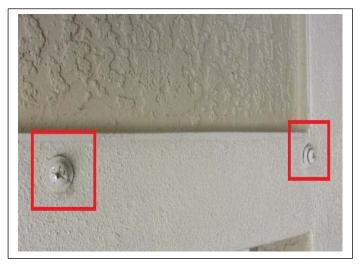
FBC# FL11964.1

OPENING PROTECTION – Permanent shutter panel mounting hardware is properly installed at ALL sliding glass door units.
