Uniform Mitigation Verification Inspection Form

Inspection Date: 09-13-2024		
Owner Information		
Owner Name: Vista Townhomes at Heritage Bay Association, Inc.		Contact Person:
Address: 9077 Gervais Circle		Home Phone:
City: Naples	Zip: 34120	Work Phone:
County: Collier		Cell Phone:
Insurance Company:		Policy #:
Year of Home: Completed in 2010	# of Stories: 2	Email:

Vista Townhomes at Heritage Bay Association, Inc.
9077 Gervais Circle, Naples, FL 34120
09-13-2024

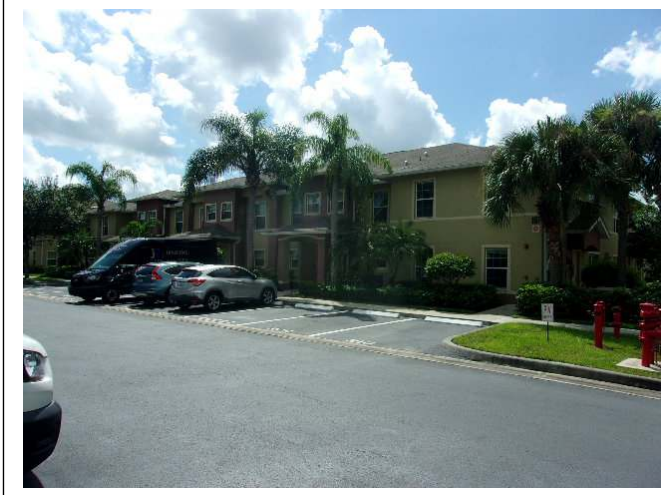
FRONT ELEVATION VIEW

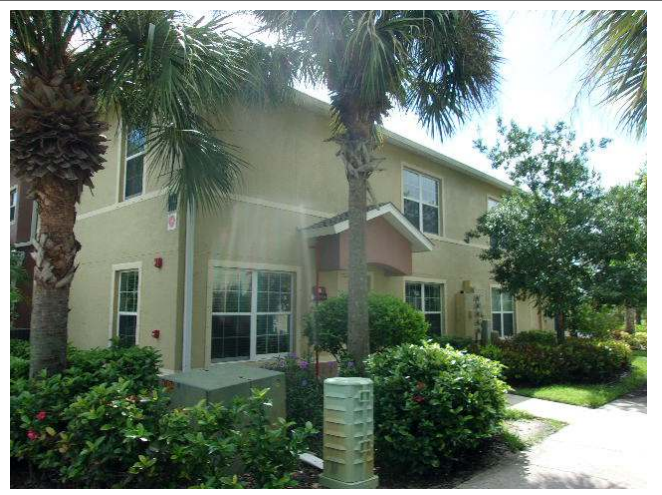
SIDE ELEVATION VIEW – The side entryway gables are not structurally connected to the main roofing system. They are attached to the reinforced walls.

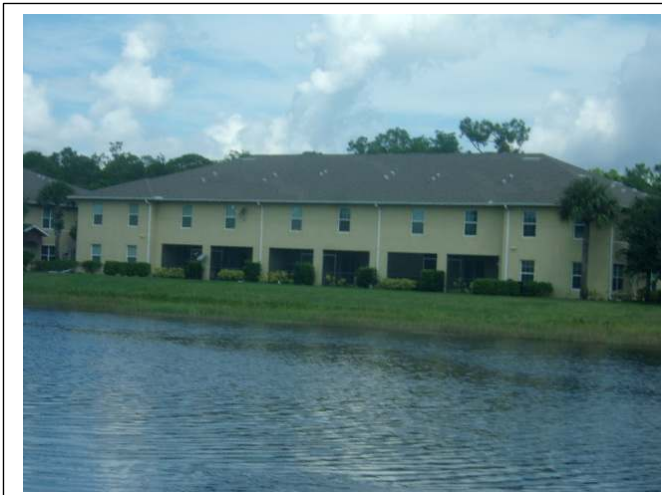
REAR ELEVATION VIEW

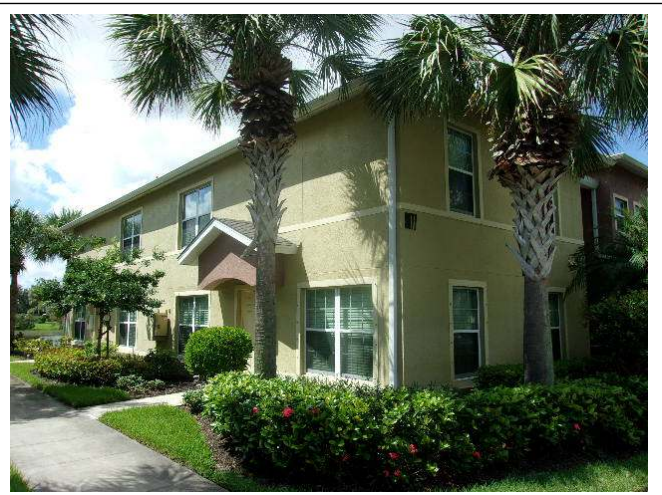
SIDE ELEVATION VIEW – The side entryway gables are not structurally connected to the main roofing system. They are attached to the reinforced walls.

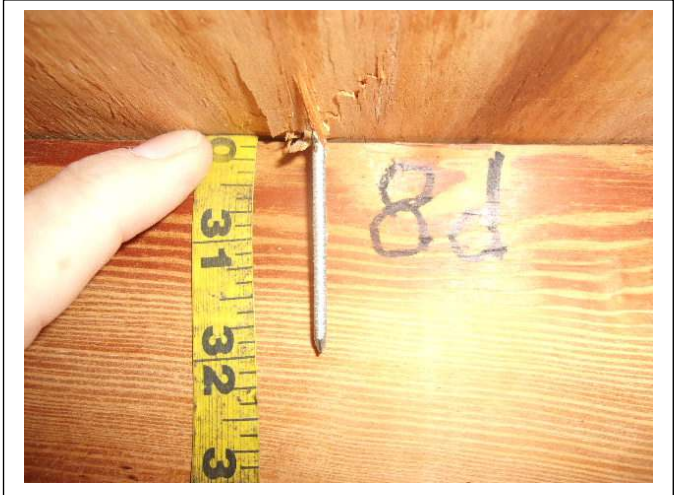
ROOF DECK ATTACHEMNT – 8d ring shank nails added in 2018. Roofing contract attached to this report.

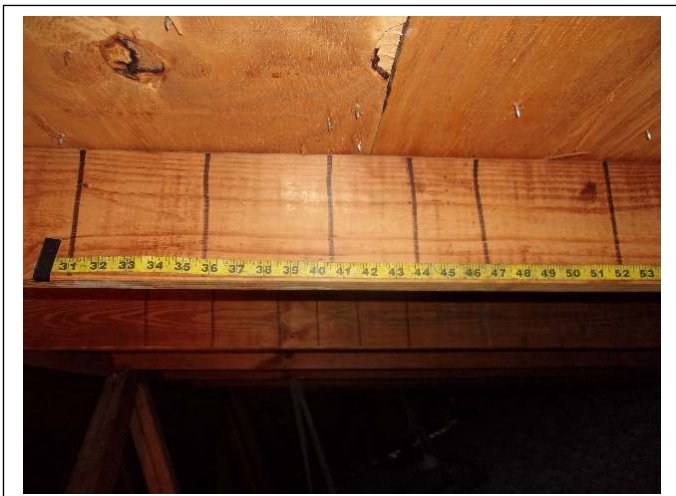
ROOF DECK ATTACHMENT – 8d nails within 6 inches along the edge

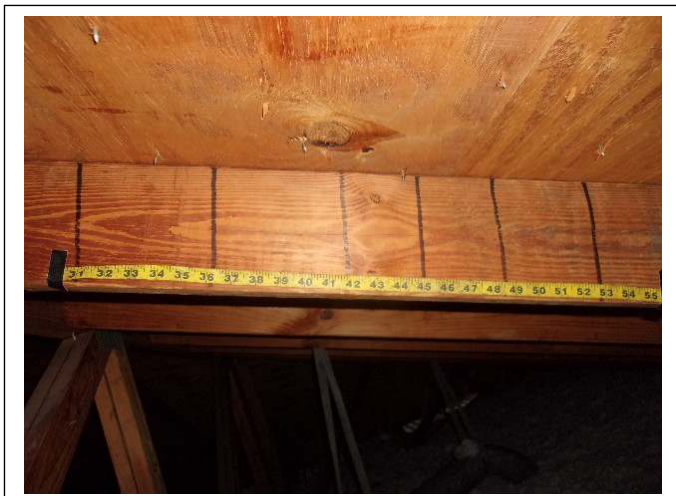
ROOF DECK ATTACHMENT – 8d nails within 6 inches in the field

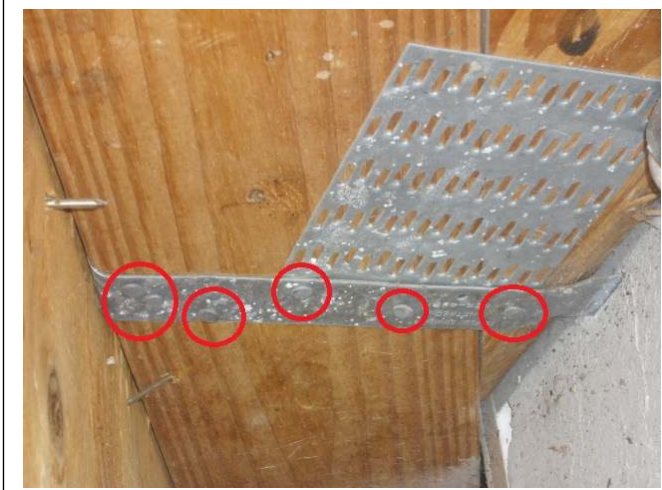
ROOF TO WALL ATTACHMENT – Properly installed
Single Wraps

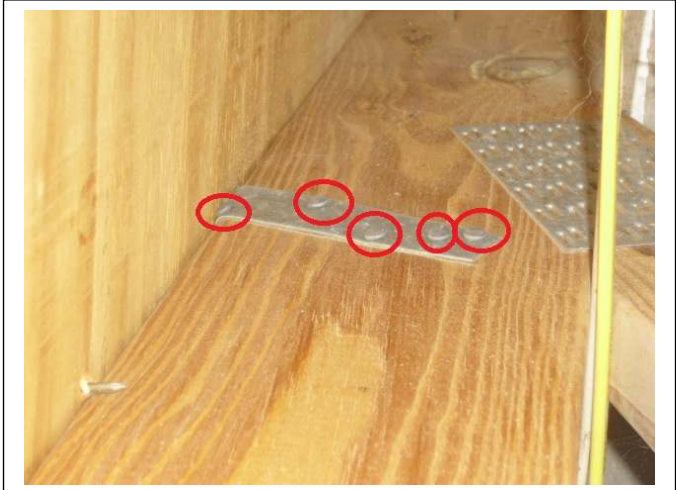
ROOF TO WALL ATTACHMENT – Properly installed
Single Wraps

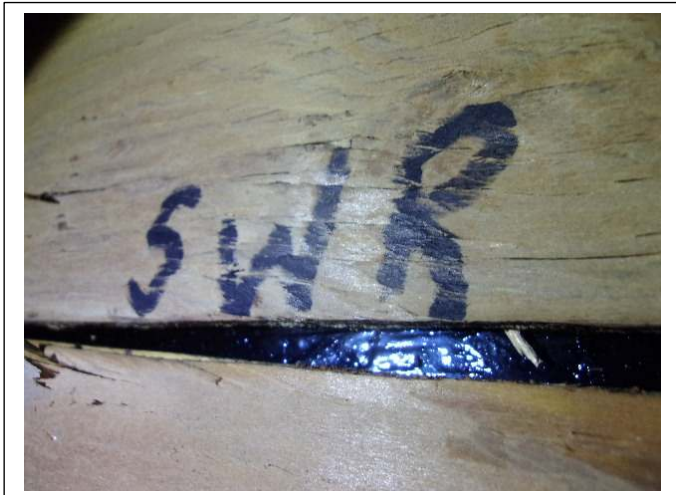
SECONDARY WATER BARRIER – A polymer adhesive
(peel & stick) SWR Barrier was installed on the entire roof
deck in 2018. Documentation attached to this report.
NOA#15-0707.09

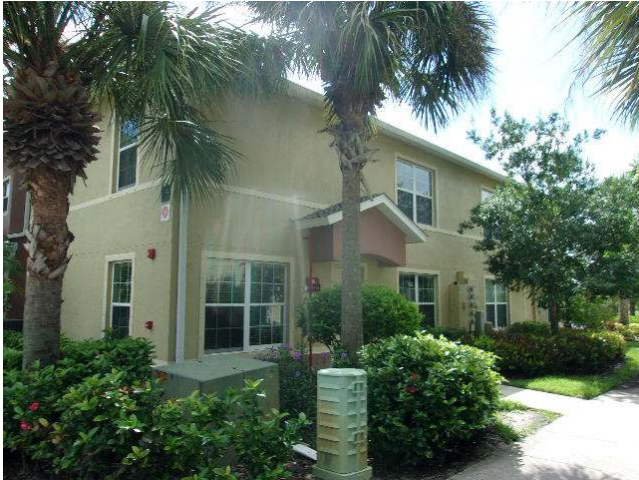
OPENING PROTECTION – The hinged entry doors cannot be identified as being impact rated, but local and FBC required the doors to be ASTM E-330 rated at a minimum.

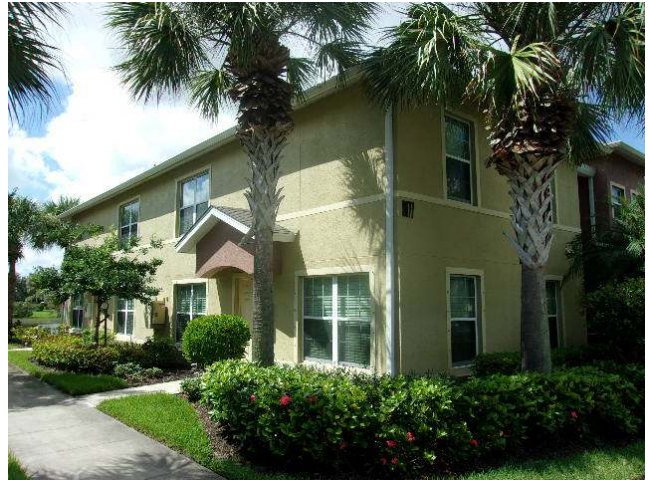
OPENING PROTECTION – The hinged entry doors cannot be identified as being impact rated, but local and FBC required the doors to be ASTM E-330 rated at a minimum.

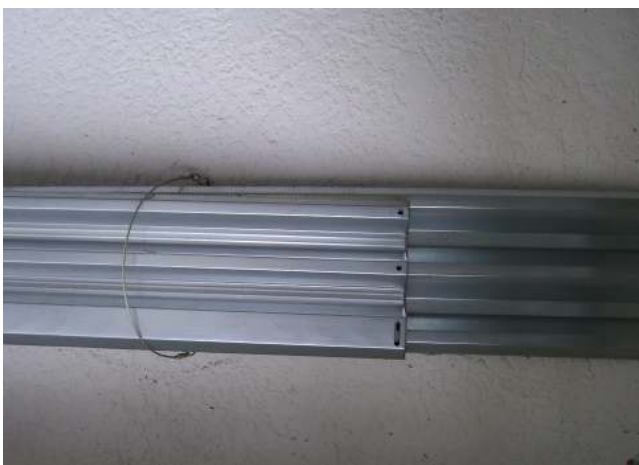
OPENING PROTECTION – Per local code and the FBC, large missile rated metal corrugated shutter panels are available to protect all glazed openings.
FBC# FL11964.1

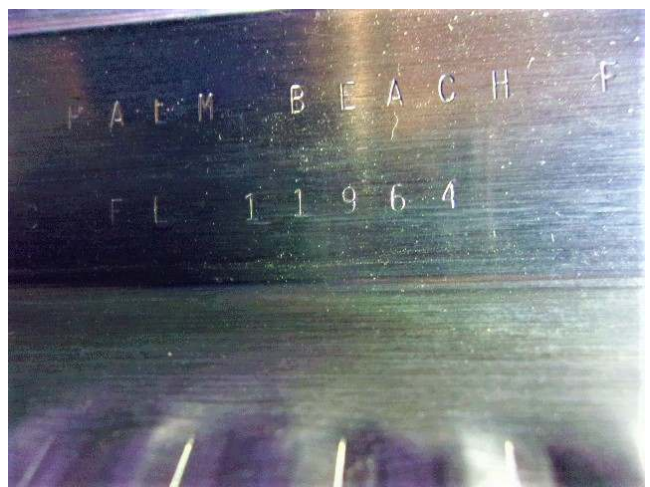
OPENING PROTECTION – The metal corrugated shutter panel's product approval stamp.
FBC# FL11964.1

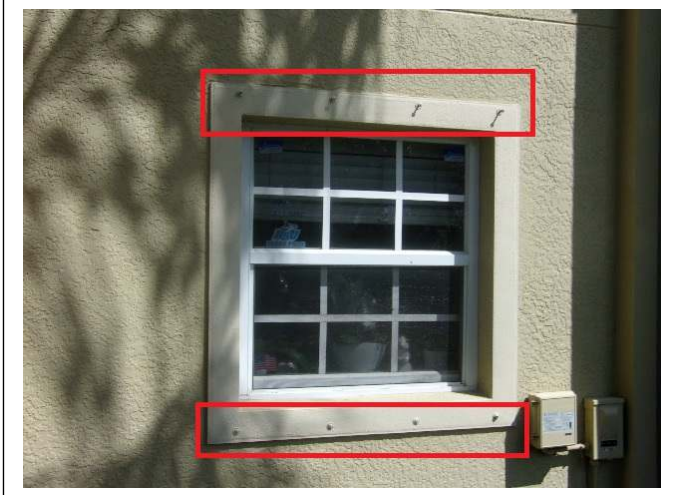
OPENING PROTECTION – Permanent shutter panel mounting hardware is properly installed at ALL window units.

FBC# FL11964.1

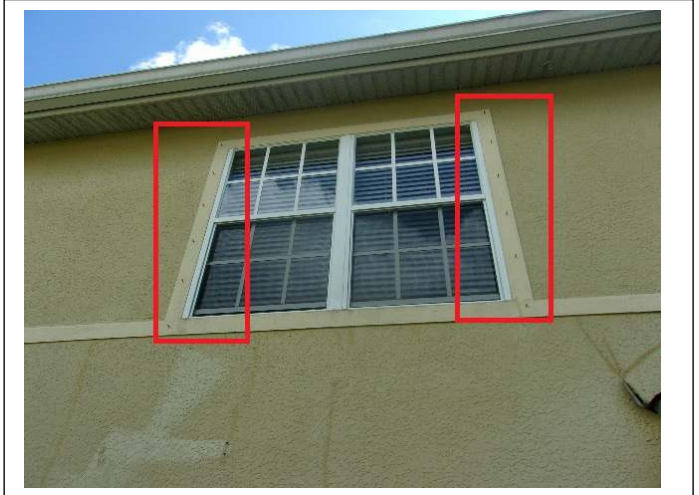
OPENING PROTECTION – Permanent shutter panel mounting hardware is properly installed at ALL window units.

FBC# FL11964.1

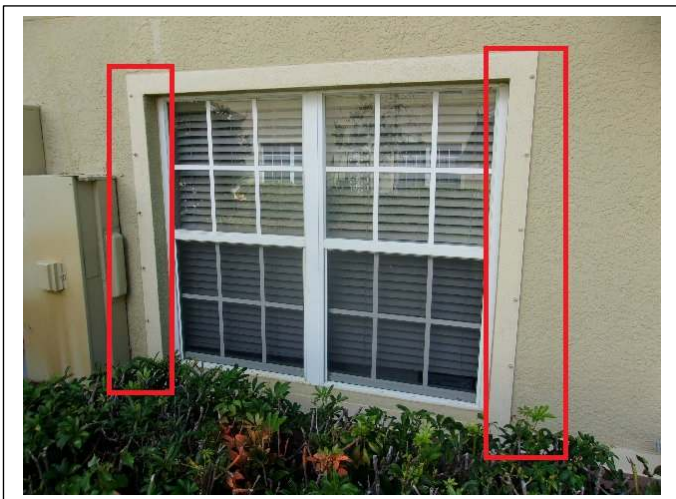
OPENING PROTECTION – Permanent shutter panel mounting hardware is properly installed at ALL window units.

FBC# FL11964.1

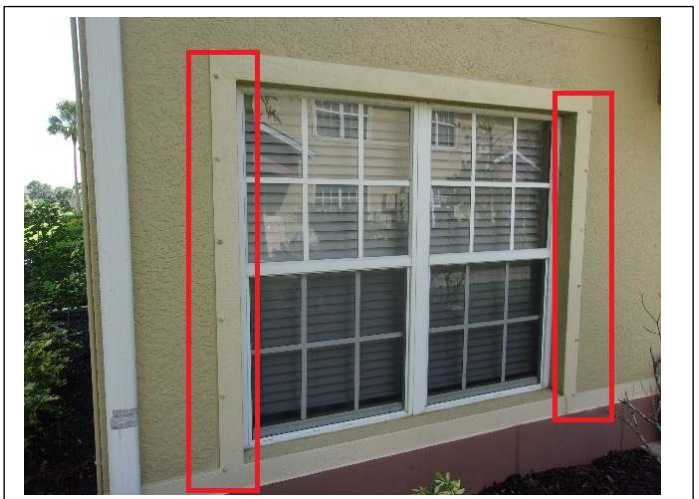
OPENING PROTECTION – Permanent shutter panel mounting hardware is properly installed at ALL window units.

FBC# FL11964.1

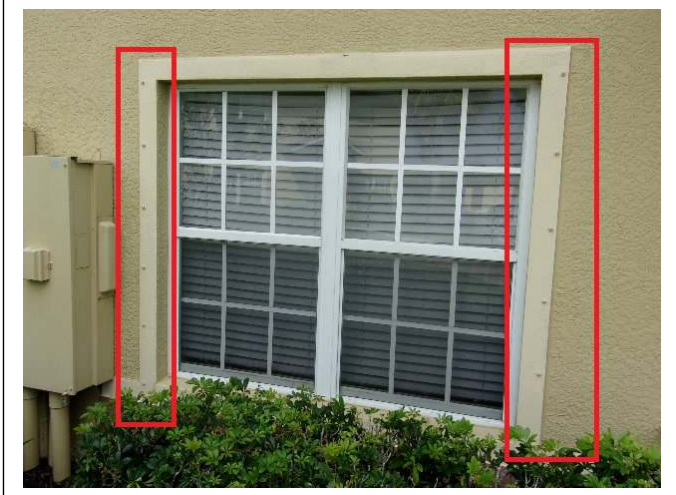
OPENING PROTECTION – Permanent shutter panel mounting hardware is properly installed at ALL window units.

FBC# FL11964.1

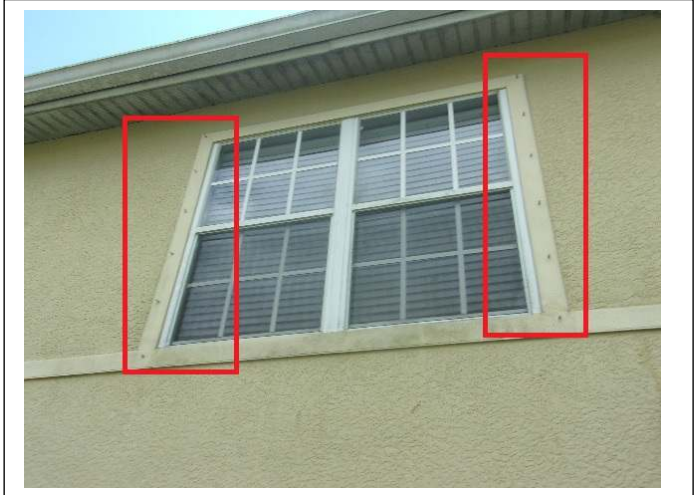
OPENING PROTECTION – Permanent shutter panel mounting hardware is properly installed at ALL window units.

FBC# FL11964.1

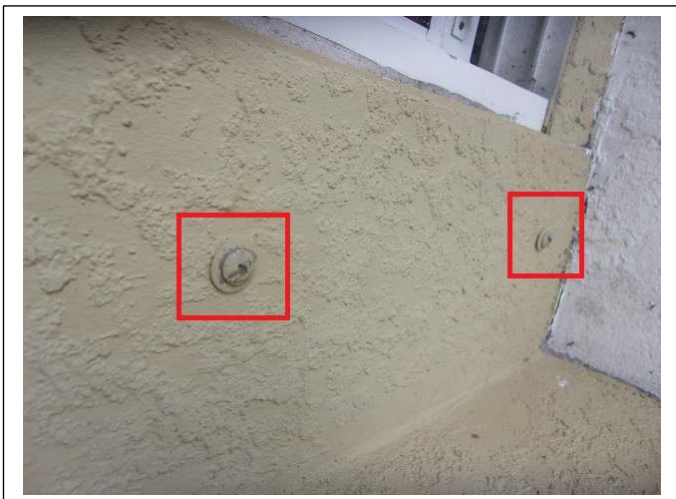
OPENING PROTECTION – Permanent shutter panel mounting hardware is properly installed at ALL window units.

FBC# FL11964.1

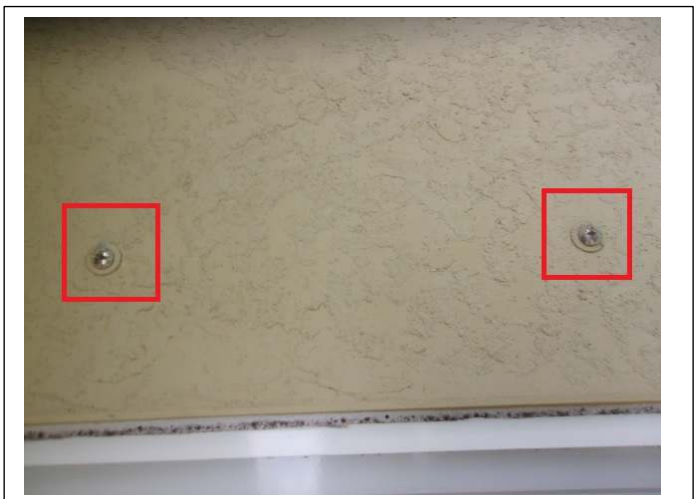
OPENING PROTECTION – Permanent shutter panel mounting hardware is properly installed at ALL window units.

FBC# FL11964.1

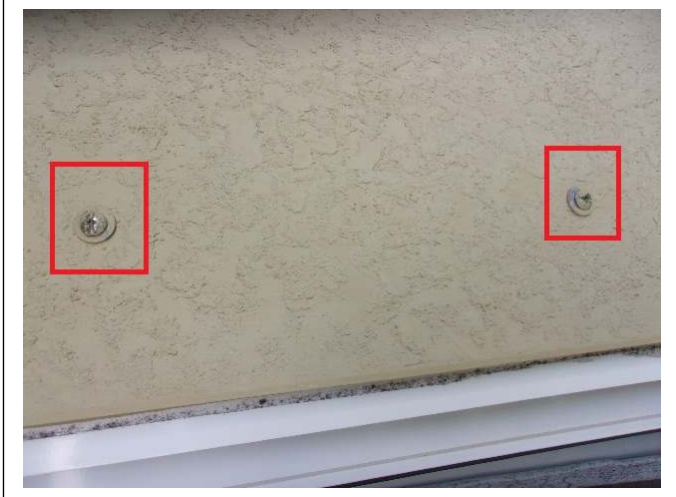
OPENING PROTECTION – Permanent shutter panel mounting hardware is properly installed at ALL window units.

FBC# FL11964.1

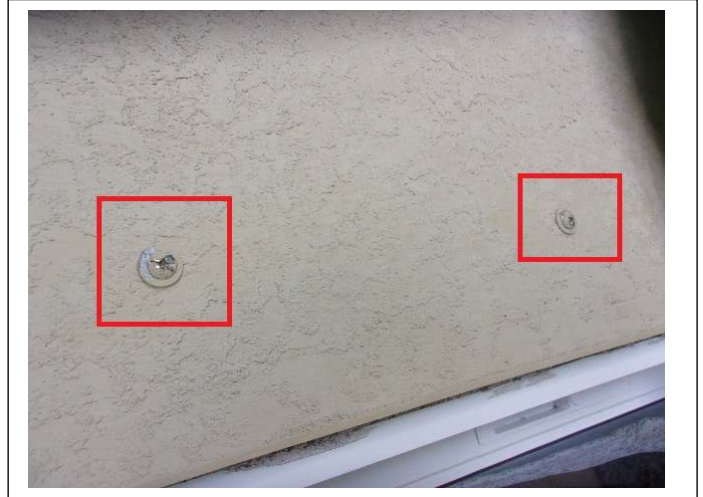
OPENING PROTECTION – Permanent shutter panel mounting hardware is properly installed at ALL window units.

FBC# FL11964.1

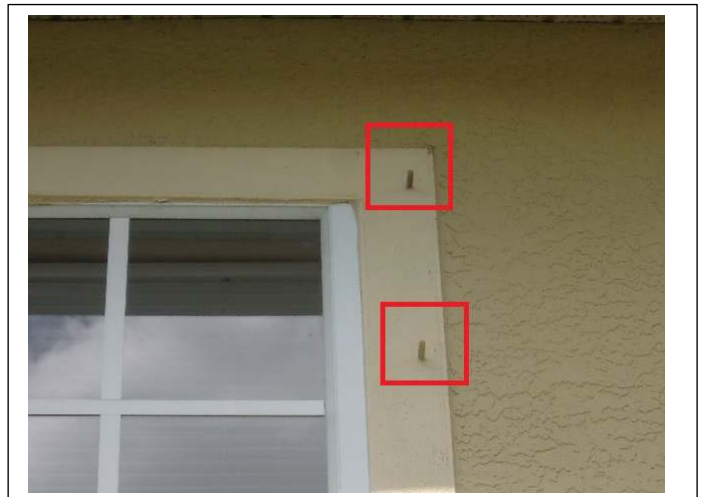
OPENING PROTECTION – Permanent shutter panel mounting hardware is properly installed at ALL window units.

FBC# FL11964.1

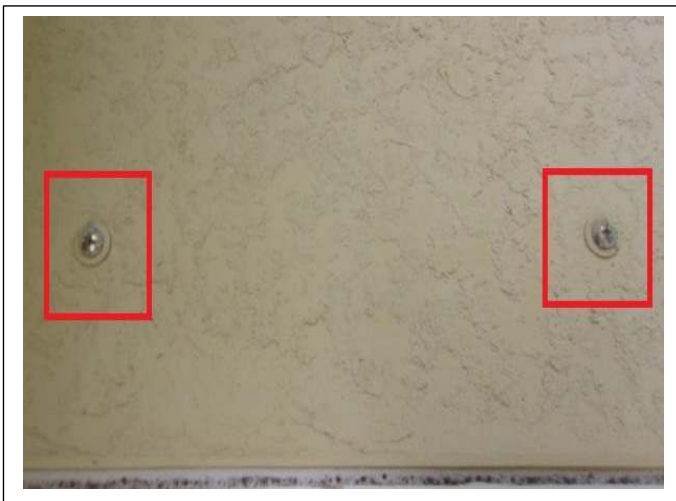
OPENING PROTECTION – Permanent shutter panel mounting hardware is properly installed at ALL sliding glass door units.
FBC# FL11964.1

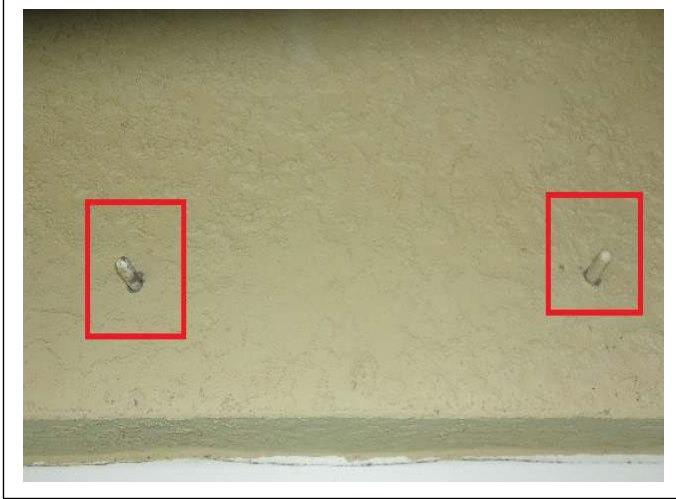
OPENING PROTECTION – Permanent shutter panel mounting hardware is properly installed at ALL sliding glass door units.
FBC# FL11964.1

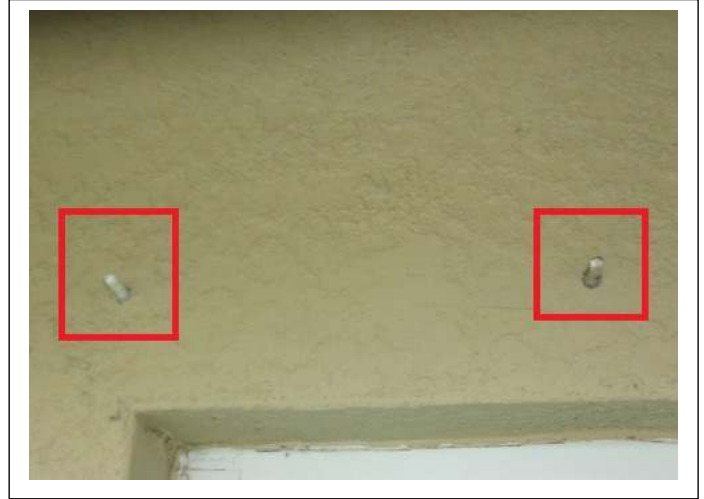
OPENING PROTECTION – Permanent shutter panel mounting hardware is properly installed at ALL sliding glass door units.
FBC# FL11964.1
