Uniform Mitigation Verification Inspection Form

Inspection Date: 09-13-2024			
Owner Information			
Owner Name: Vista Townhomes at Herita	ge Bay Association, Inc.	Contact Person:	
Address: 9084 Gervais Circle		Home Phone:	
City: Naples	Zip: <b>34120</b>	Work Phone:	
County: Collier		Cell Phone:	
Insurance Company:		Policy #:	
Year of Home: Completed in 2011	# of Stories: 2	Email:	
NOTE: Any documentation used in valid accompany this form. At least one photogous though 7. The insurer may ask additional	graph must accompany this form to valid l questions regarding the mitigated featu	ate each attribute marked re(s) verified on this form	l in questions 3
<ul> <li>A. Built in compliance with the FBC a date after 3/1/2002: Building Perm</li> <li>B. For the HVHZ Only: Built in con</li> </ul>	unties), South Florida Building Code (SFBC): Year Built For homes built ait Application Date (MM/DD/YYYY)	2-94)? in 2002/2003 provide a per 11 For homes built in 19	mit application with 94, 1995, and 1996

Inspectors Initials RD Property Address	ss_9084 Gervais Circle

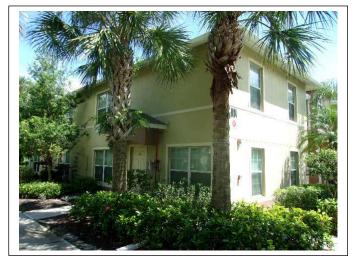
SIDE ELEVATION VIEW – The side entryway gables are not structurally connected to the main roofing system.

They are attached to the reinforced walls.

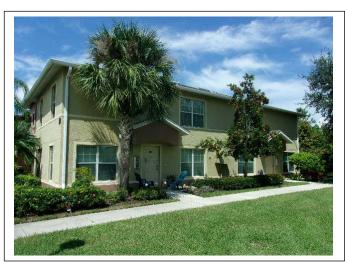
SIDE ELEVATION VIEW – The side entryway gables are not structurally connected to the main roofing system. They are attached to the reinforced walls.

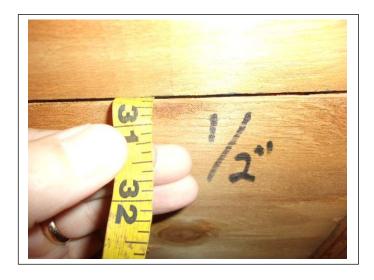
ROOF DECK THICKNESS –  $\frac{1}{2}$  inch plywood

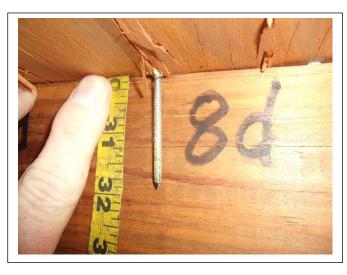
ROOF DECK ATTACHEMNT – 8d ring shank nails added in 2018. Roofing contract attached to this report.

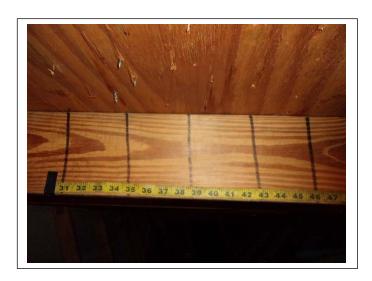
ROOF DECK ATTACHMENT – 8d nails within 6 inches along the edge

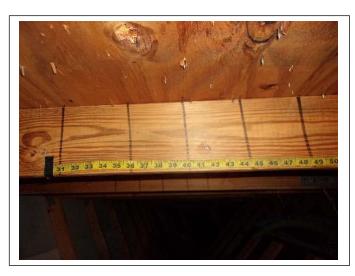
ROOF DECK ATTACHMENT – 8d nails within 6 inches in the field

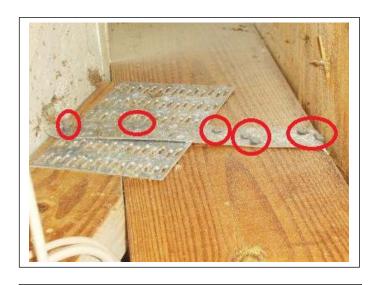
ROOF TO WALL ATTACHMENT – Properly installed Single Wraps

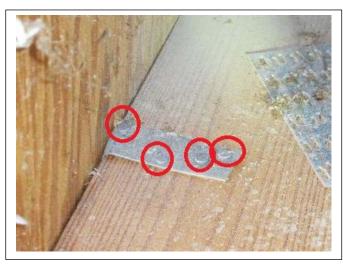
ROOF TO WALL ATTACHMENT – Properly installed Single Wraps

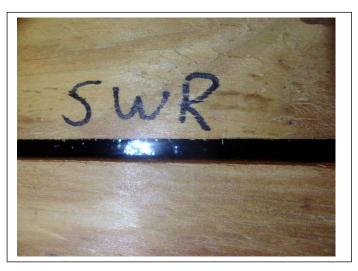
NOA#15-0707.09

SECONDARY WATER BARRIER – A polymer adhesive (peel & stick) SWR Barrier was installed on the entire roof deck in 2018. Documentation attached to this report.

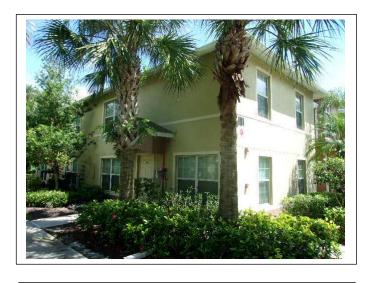
OPENING PROTECTION – The hinged entry doors cannot be identified as being impact rated, but local and FBC required the doors to be ASTM E-330 rated at a minimum.

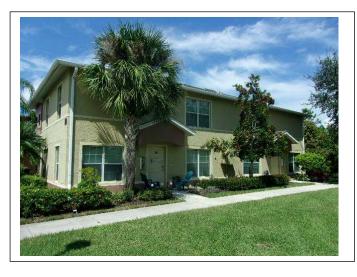
OPENING PROTECTION – The hinged entry doors cannot be identified as being impact rated, but local and FBC required the doors to be ASTM E-330 rated at a minimum.

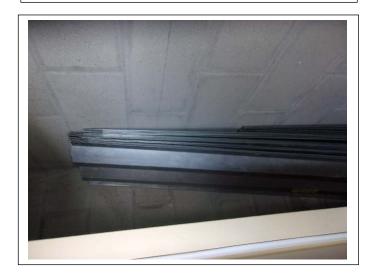
FBC# FL11964.1

OPENING PROTECTION – Per local code and the FBC, large missile rated metal corrugated shutter panels are available to protect all glazed openings.

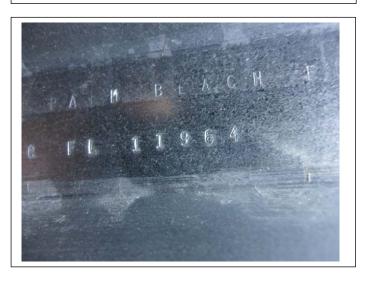
OPENING PROTECTION – The metal corrugated shutter panel's product approval stamp. FBC# FL11964.1

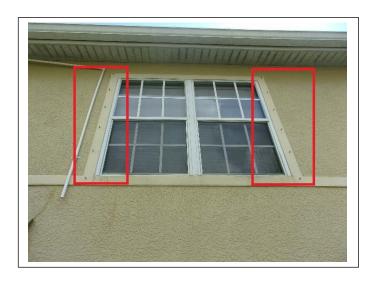
FBC# FL11964.1

OPENING PROTECTION – Permanent shutter panel mounting hardware is properly installed at ALL window units.

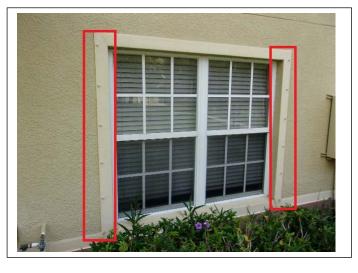
FBC# FL11964.1

OPENING PROTECTION – Permanent shutter panel mounting hardware is properly installed at ALL window units.

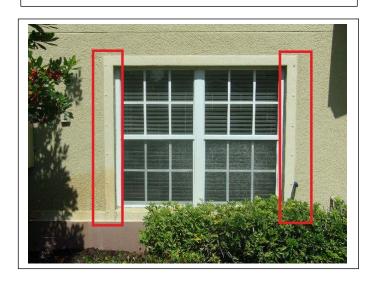
FBC# FL11964.1

OPENING PROTECTION – Permanent shutter panel mounting hardware is properly installed at ALL window units.

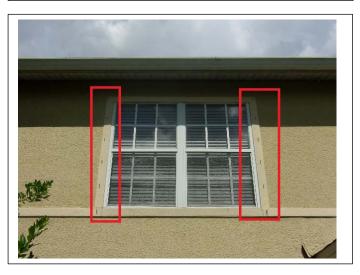
FBC# FL11964.1

OPENING PROTECTION – Permanent shutter panel mounting hardware is properly installed at ALL window units.

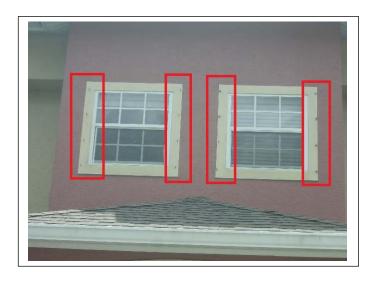
FBC# FL11964.1

OPENING PROTECTION – Permanent shutter panel mounting hardware is properly installed at ALL window units.

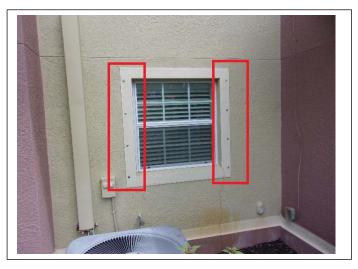
FBC# FL11964.1

OPENING PROTECTION – Permanent shutter panel mounting hardware is properly installed at ALL window units.

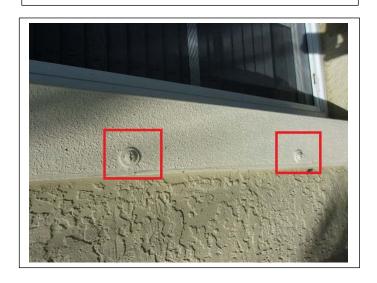
FBC# FL11964.1

OPENING PROTECTION – Permanent shutter panel mounting hardware is properly installed at ALL window units.

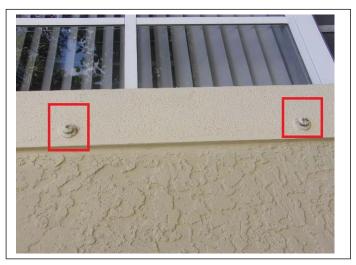
FBC# FL11964.1

OPENING PROTECTION – Permanent shutter panel mounting hardware is properly installed at ALL window units.

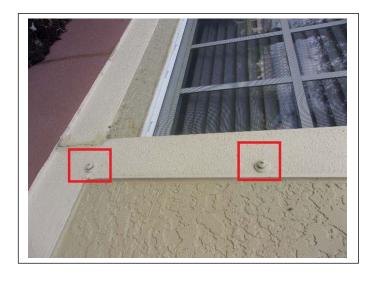
FBC# FL11964.1

OPENING PROTECTION – Permanent shutter panel mounting hardware is properly installed at ALL window units.

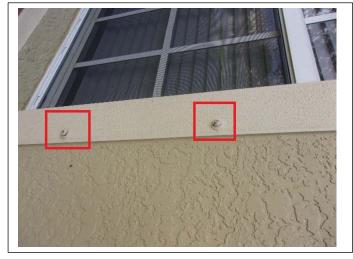
FBC# FL11964.1

OPENING PROTECTION – Permanent shutter panel mounting hardware is properly installed at ALL window units.

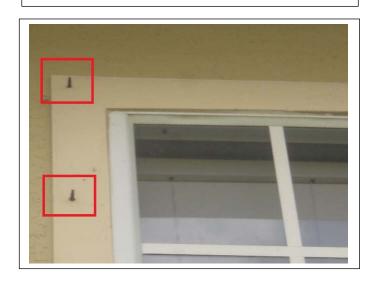
FBC# FL11964.1

OPENING PROTECTION – Permanent shutter panel mounting hardware is properly installed at ALL window units.

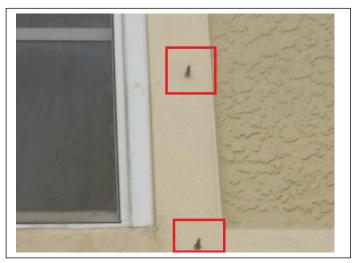
FBC# FL11964.1

OPENING PROTECTION – Permanent shutter panel mounting hardware is properly installed at ALL window units.

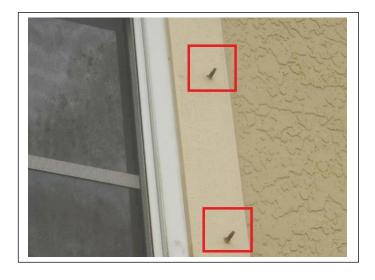
OPENING PROTECTION – The window unit's product approval. FBC# FL42.2

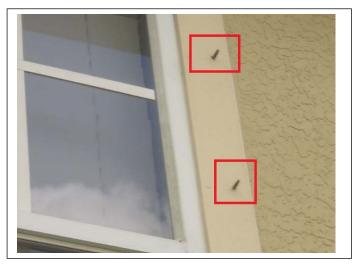
OPENING PROTECTION – The window unit's product approval.
FBC# FL42.2

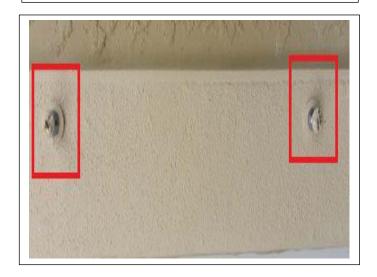
FBC# FL11964.1

OPENING PROTECTION – Permanent shutter panel mounting hardware is properly installed at ALL sliding glass door units.

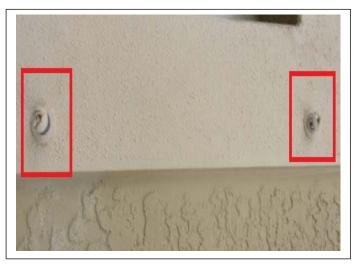
FBC# FL11964.1

OPENING PROTECTION – Permanent shutter panel mounting hardware is properly installed at ALL sliding glass door units.

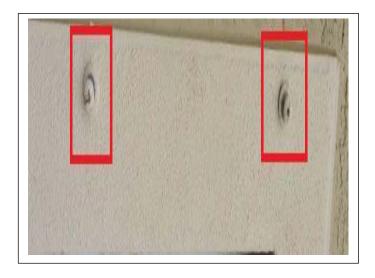
OPENING PROTECTION – Permanent shutter panel mounting hardware is properly installed at ALL sliding glass door units.
FBC# FL11964.1
