Uniform Mitigation Verification Inspection Form

Inspection Date: 09-13-2024			-
Owner Information			
Owner Name: Vista Townhomes at Heritag	ge Bay Association, Inc.	Contact Person:	
Address: 9085 Gervais Circle		Home Phone:	
City: Naples	Zip: 34120	Work Phone:	
County: Collier		Cell Phone:	
Insurance Company:		Policy #:	
Year of Home: Completed in 2011	# of Stories: 2	Email:	
accompany this form. At least one photog	ating the compliance or existence of each cograph must accompany this form to validated questions regarding the mitigated feature(each attribute marked i	
the HVHZ (Miami-Dade or Broward could be a date after 3/1/2002: Building Perm B. For the HVHZ Only: Built in con	npliance with the SFBC-94: Year Builtdate after 9/1/1994: Building Permit Application	4)? 2002/2003 provide a permi . For homes built in 1994	it application with 4, 1995, and 1996
OR Year of Original Installation/Replace	types in use. Provide the permit application datement OR indicate that no information was available.

Inspectors Initials RD Property Address	ss_9085 Gervais Circle		<u>-</u>

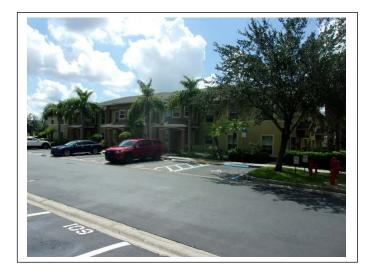
FRONT ELEVATION VIEW

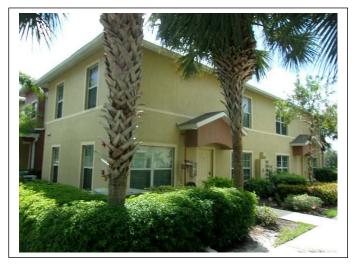
SIDE ELEVATION VIEW – The side entryway gables are not structurally connected to the main roofing system.

They are attached to the reinforced walls.

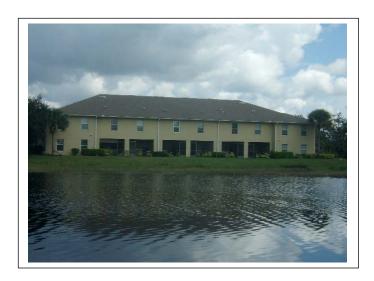
REAR ELEVATION VIEW

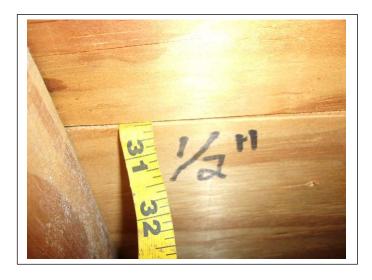
ROOF DECK THICKNESS – $\frac{1}{2}$ inch plywood

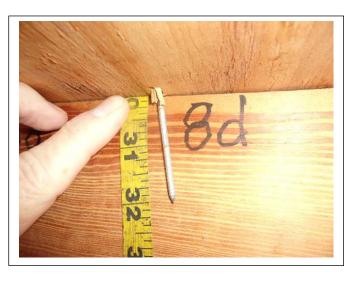
ROOF DECK ATTACHEMNT – 8d ring shank nails added in 2018. Roofing contract attached to this report.

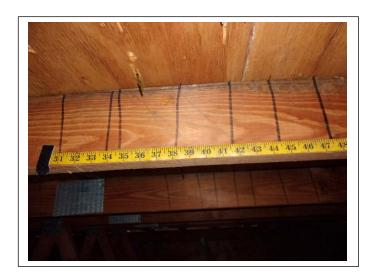
ROOF DECK ATTACHMENT – 8d nails within 6 inches along the edge

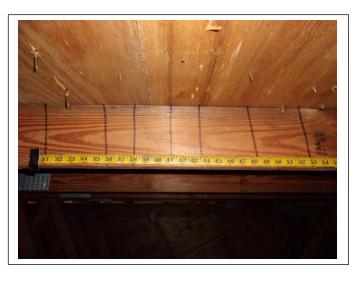
ROOF DECK ATTACHMENT – 8d nails within 6 inches in the field

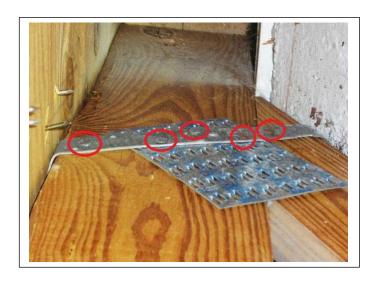
ROOF TO WALL ATTACHMENT – Properly installed Single Wraps

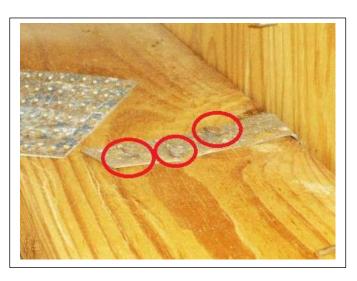
ROOF TO WALL ATTACHMENT – Properly installed Single Wraps

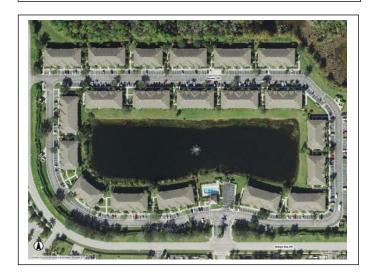
ROOF GEOMETRY – Aerial view of the Hip Roof Shape.

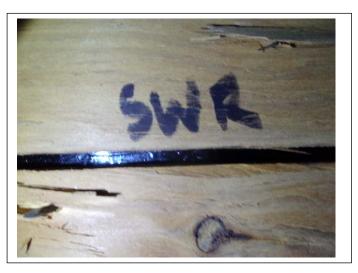
NOA#15-0707.09

SECONDARY WATER BARRIER – A polymer adhesive (peel & stick) SWR Barrier was installed on the entire roof deck in 2018. Documentation attached to this report.

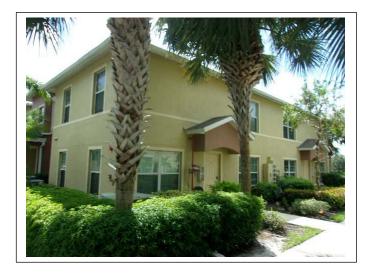
OPENING PROTECTION – The hinged entry doors cannot be identified as being impact rated, but local and FBC required the doors to be ASTM E-330 rated at a minimum.

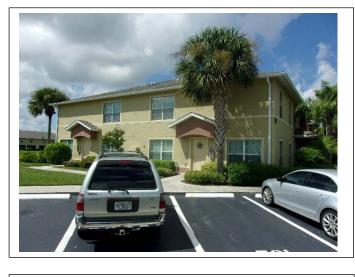
OPENING PROTECTION – The hinged entry doors cannot be identified as being impact rated, but local and FBC required the doors to be ASTM E-330 rated at a minimum.

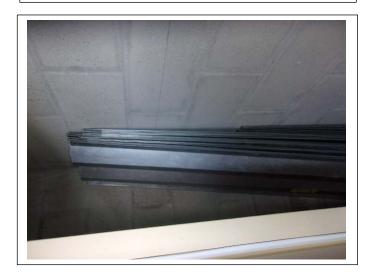
FBC# FL11964.1

OPENING PROTECTION – Per local code and the FBC, large missile rated metal corrugated shutter panels are available to protect all glazed openings.

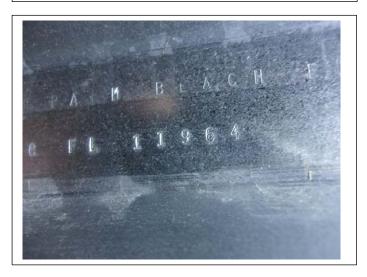
OPENING PROTECTION – The metal corrugated shutter panel's product approval stamp. FBC# FL11964.1

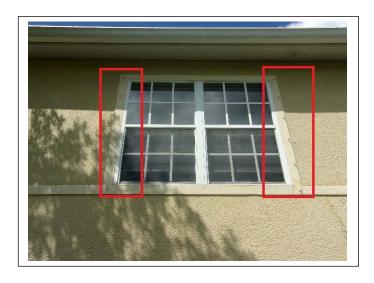
FBC# FL11964.1

OPENING PROTECTION – Permanent shutter panel mounting hardware is properly installed at ALL window units.

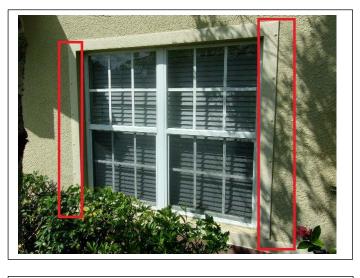
FBC# FL11964.1

OPENING PROTECTION – Permanent shutter panel mounting hardware is properly installed at ALL window units.

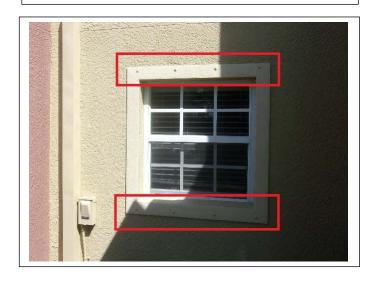
FBC# FL11964.1

OPENING PROTECTION – Permanent shutter panel mounting hardware is properly installed at ALL window units.

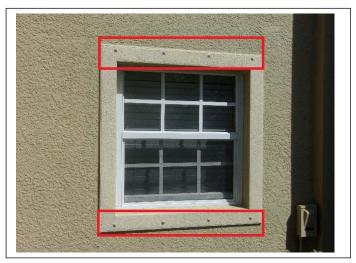
FBC# FL11964.1

OPENING PROTECTION – Permanent shutter panel mounting hardware is properly installed at ALL window units.

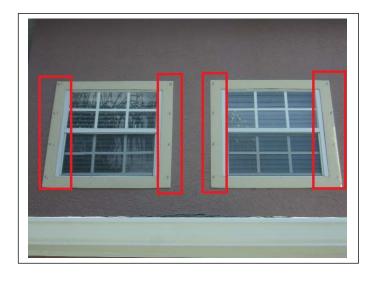
FBC# FL11964.1

OPENING PROTECTION – Permanent shutter panel mounting hardware is properly installed at ALL window units.

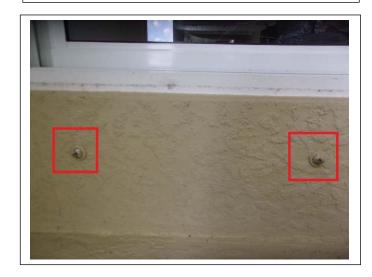
FBC# FL11964.1

OPENING PROTECTION – Permanent shutter panel mounting hardware is properly installed at ALL window units.

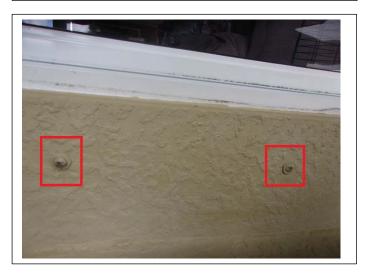
FBC# FL11964.1

OPENING PROTECTION – Permanent shutter panel mounting hardware is properly installed at ALL window units.

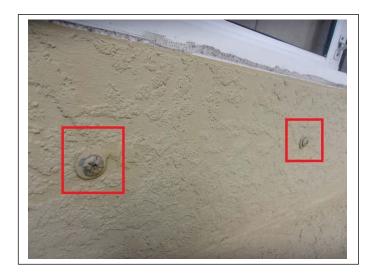
FBC# FL11964.1

OPENING PROTECTION – Permanent shutter panel mounting hardware is properly installed at ALL window units.

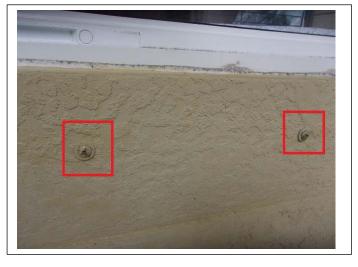
FBC# FL11964.1

OPENING PROTECTION – Permanent shutter panel mounting hardware is properly installed at ALL window units.

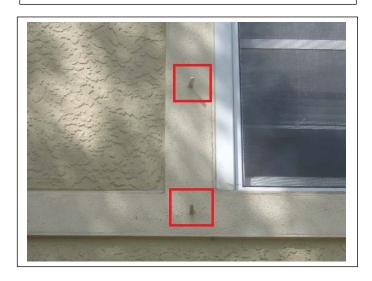
FBC# FL11964.1

OPENING PROTECTION – Permanent shutter panel mounting hardware is properly installed at ALL window units.

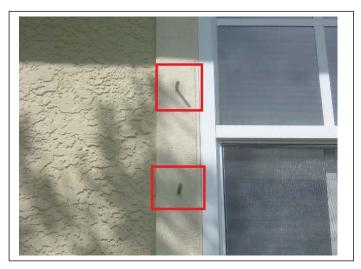
FBC# FL11964.1

OPENING PROTECTION – Permanent shutter panel mounting hardware is properly installed at ALL window units.

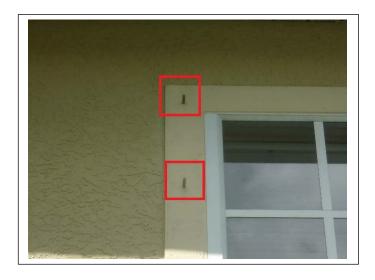
OPENING PROTECTION – The window unit's product approval. FBC# FL42.2

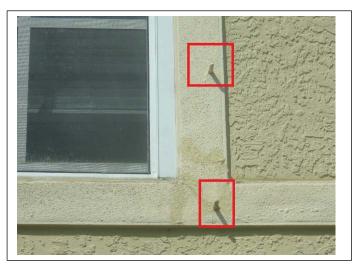
OPENING PROTECTION – The window unit's product approval.
FBC# FL42.2

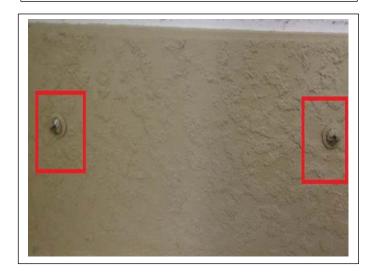
FBC# FL11964.1

OPENING PROTECTION – Permanent shutter panel mounting hardware is properly installed at ALL sliding glass door units.

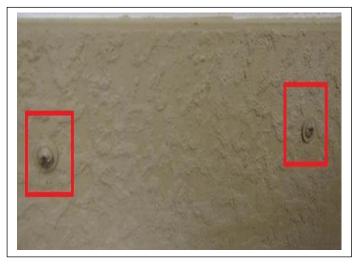
FBC# FL11964.1

OPENING PROTECTION – Permanent shutter panel mounting hardware is properly installed at ALL sliding glass door units.

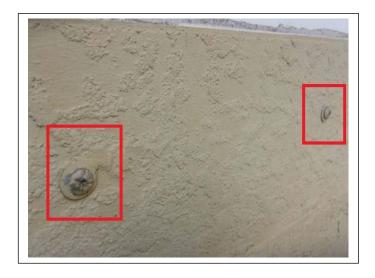
OPENING PROTECTION – Permanent shutter panel mounting hardware is properly installed at ALL sliding glass door units.
FBC# FL11964.1

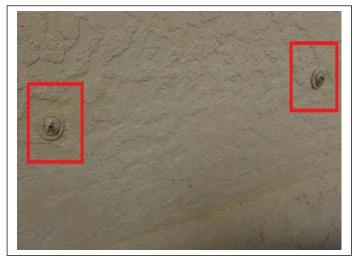
FBC# FL11964.1

OPENING PROTECTION – Permanent shutter panel mounting hardware is properly installed at ALL sliding glass door units.
