Uniform Mitigation Verification Inspection Form

Inspection Date: 09-13-2024		
Owner Information		
Owner Name: Vista Townhomes at Heritage Bay Association, Inc.		Contact Person:
Address: 9097 Gervais Circle		Home Phone:
City: Naples	Zip: 34120	Work Phone:
County: Collier	Cell Phone:	
Insurance Company:		Policy #:
Year of Home: Completed in 2012	# of Stories: 2	Email:

Inspectors Initials RD Property Address 9097 Gervais Circle

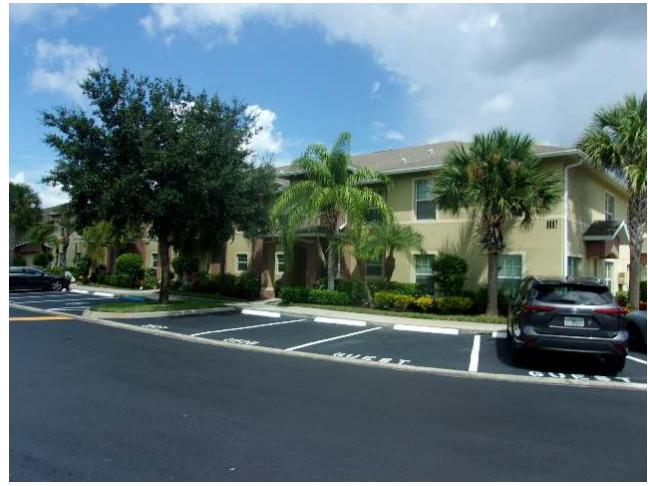
FRONT ELEVATION VIEW

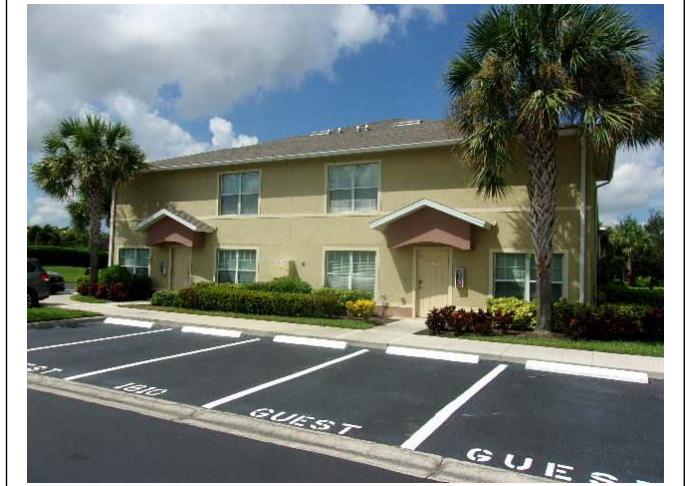
SIDE ELEVATION VIEW – The side entryway gables are not structurally connected to the main roofing system. They are attached to the reinforced walls.

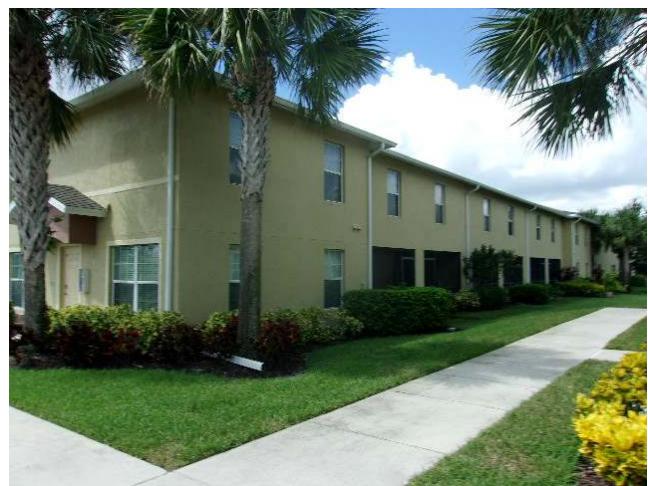
REAR ELEVATION VIEW

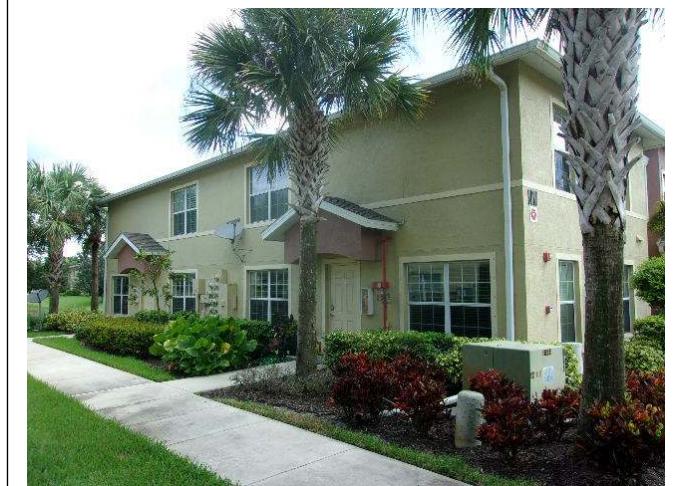
SIDE ELEVATION VIEW – The side entryway gables are not structurally connected to the main roofing system. They are attached to the reinforced walls.

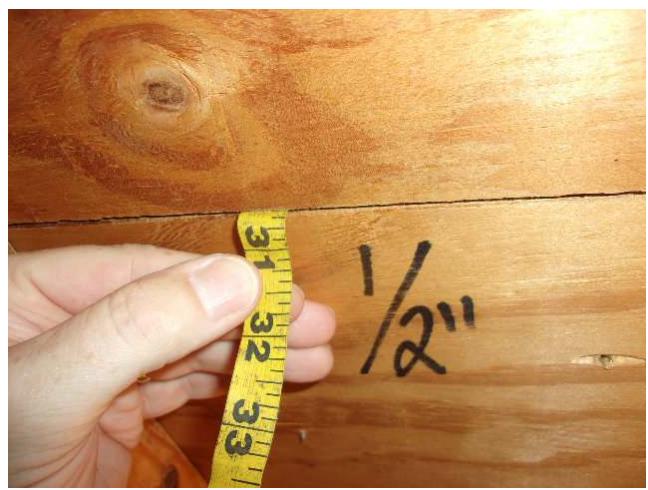
ROOF DECK THICKNESS – $\frac{1}{2}$ inch plywood

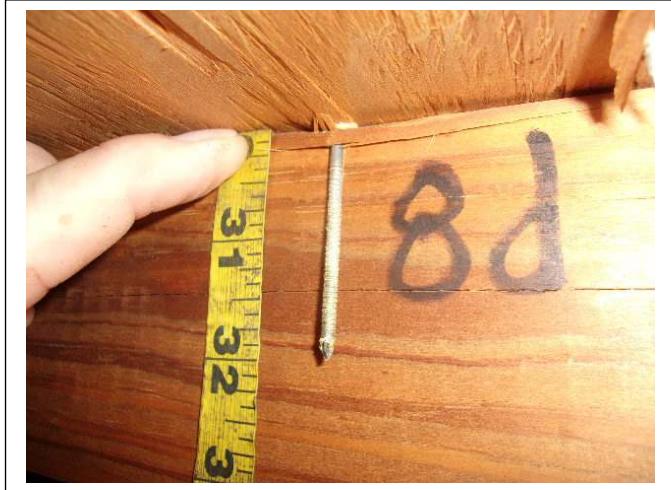
ROOF DECK ATTACHEMNT – 8d ring shank nails added in 2018. Roofing contract attached to this report.

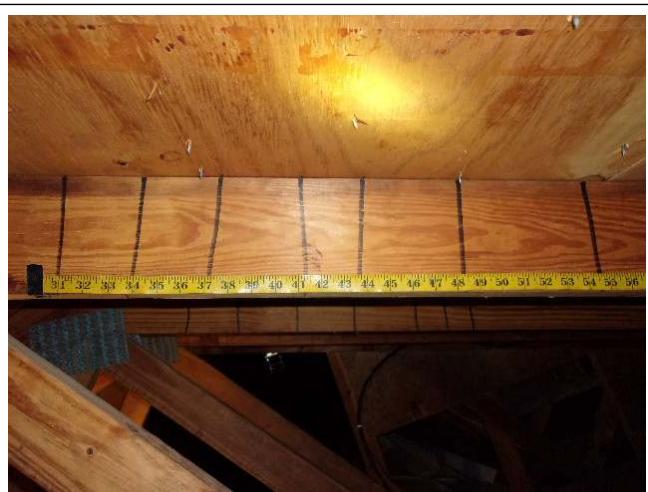
ROOF DECK ATTACHMENT – 8d nails within 6 inches along the edge

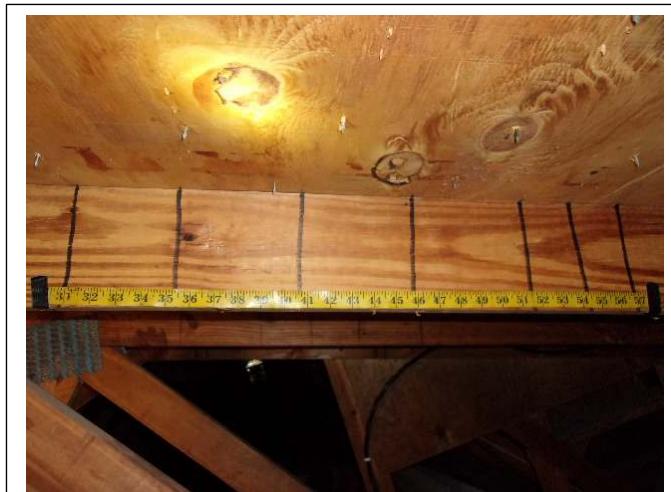
ROOF DECK ATTACHMENT – 8d nails within 6 inches in the field

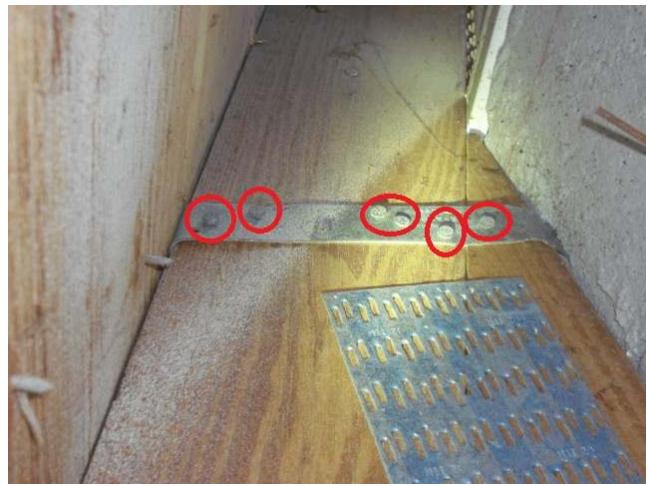
ROOF TO WALL ATTACHMENT – Properly installed Single Wraps

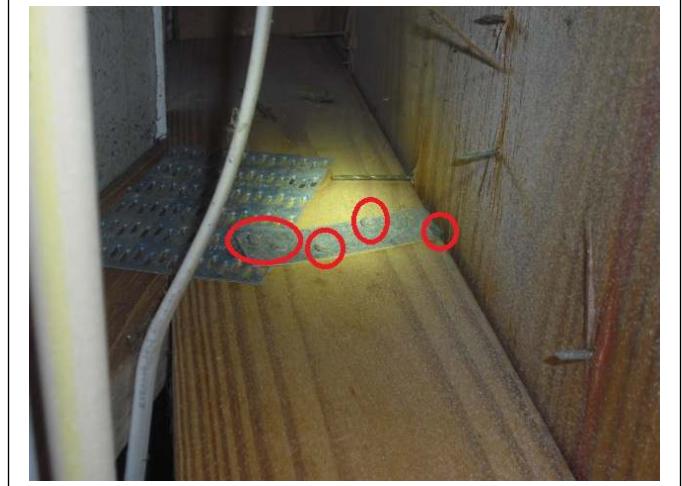
ROOF TO WALL ATTACHMENT – Properly installed Single Wraps

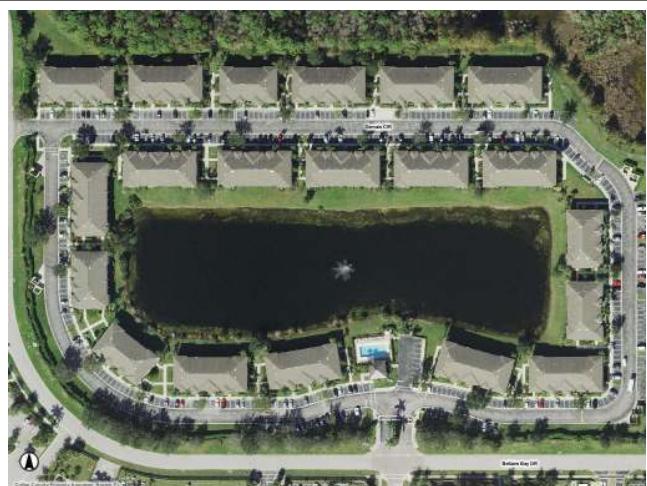
ROOF GEOMETRY – Aerial view of the Hip Roof Shape.

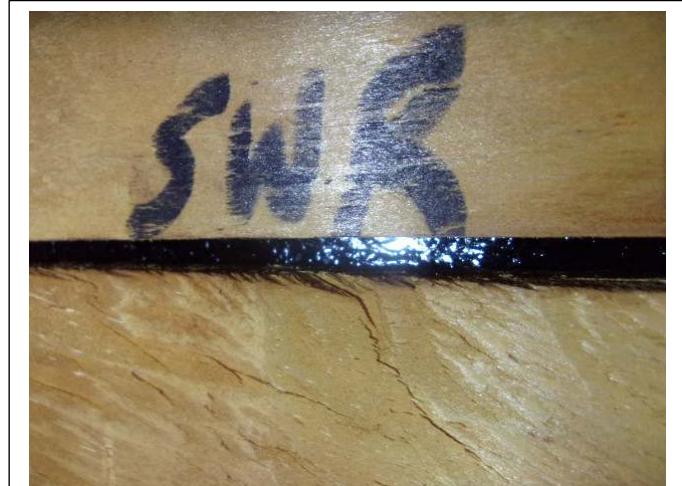
SECONDARY WATER BARRIER – A polymer adhesive (peel & stick) SWR Barrier was installed on the entire roof deck in 2018. Documentation attached to this report.
NOA#15-0707.09

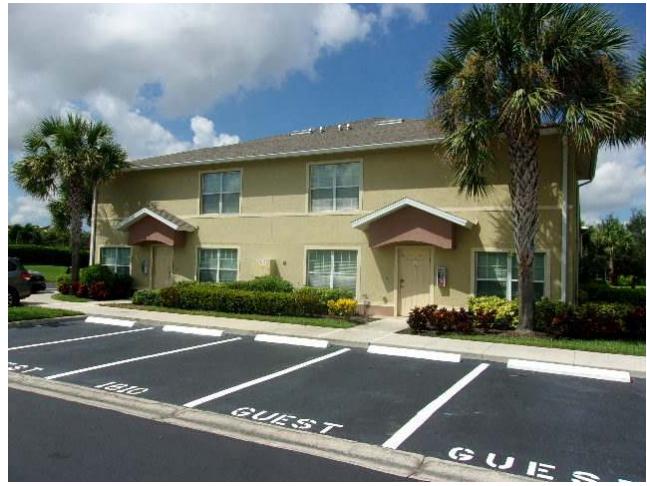
OPENING PROTECTION – The hinged entry doors cannot be identified as being impact rated, but local and FBC required the doors to be ASTM E-330 rated at a minimum.

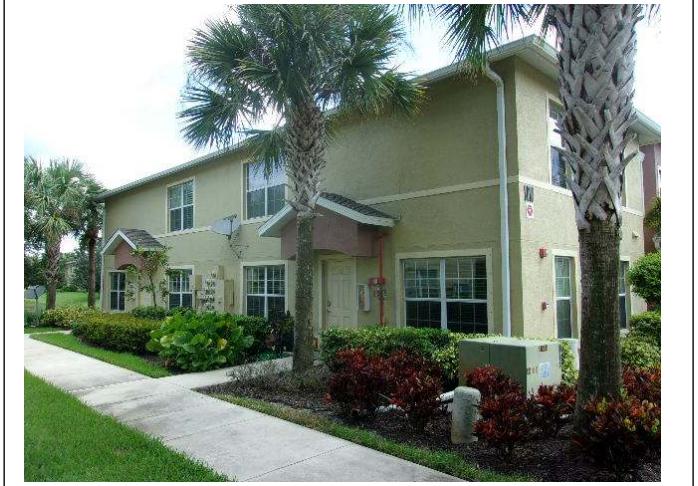
OPENING PROTECTION – The hinged entry doors cannot be identified as being impact rated, but local and FBC required the doors to be ASTM E-330 rated at a minimum.

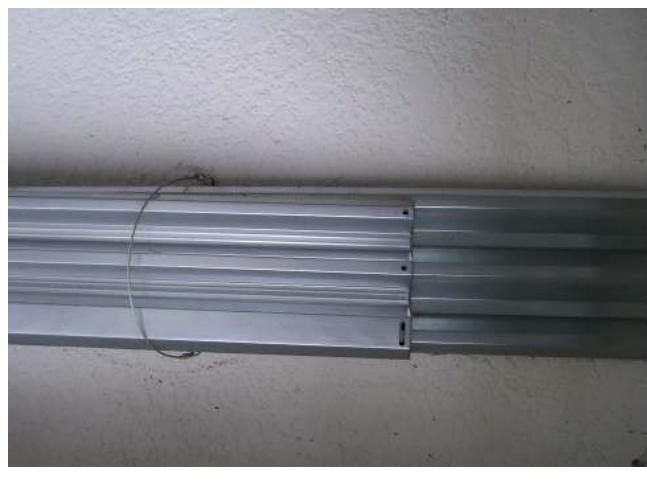
OPENING PROTECTION – Per local code and the FBC, large missile rated metal corrugated shutter panels are available to protect all glazed openings.
FBC# FL11964.1

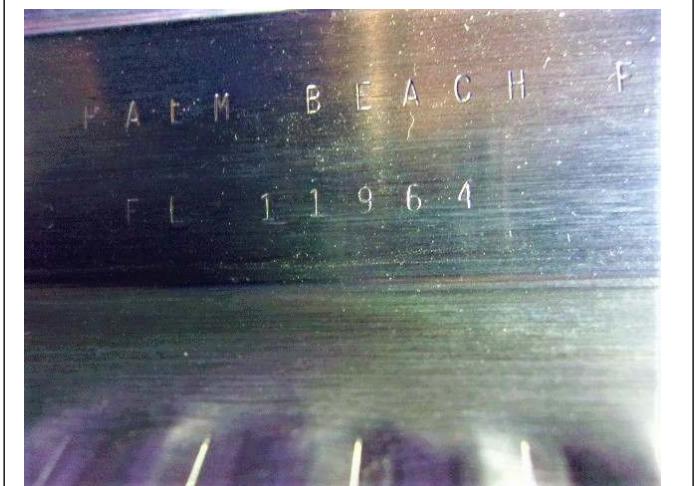
OPENING PROTECTION – The metal corrugated shutter panel's product approval stamp.
FBC# FL11964.1

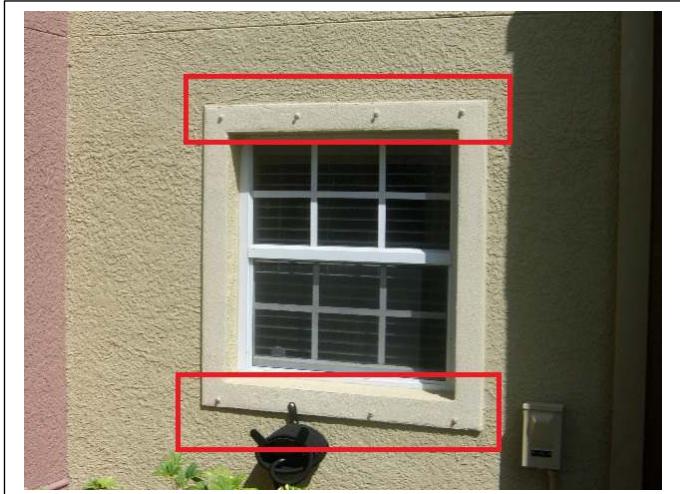
OPENING PROTECTION – Permanent shutter panel mounting hardware is properly installed at ALL window units.

FBC# FL11964.1

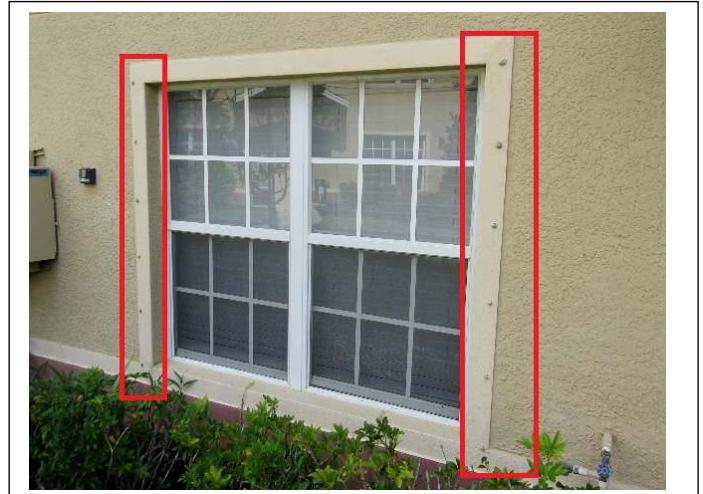
OPENING PROTECTION – Permanent shutter panel mounting hardware is properly installed at ALL window units.

FBC# FL11964.1

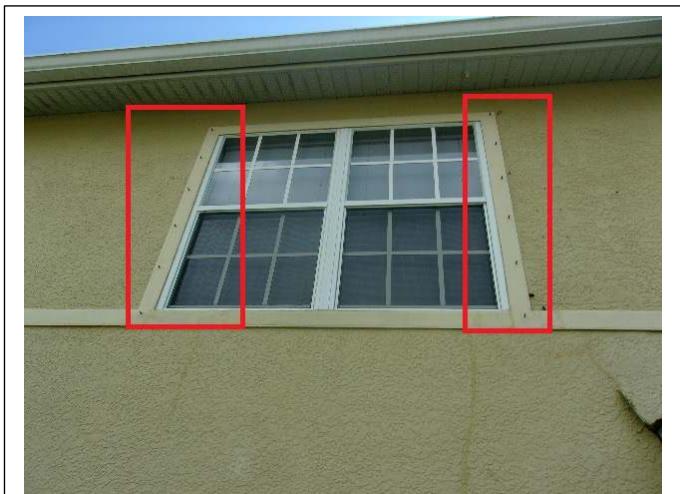
OPENING PROTECTION – Permanent shutter panel mounting hardware is properly installed at ALL window units.

FBC# FL11964.1

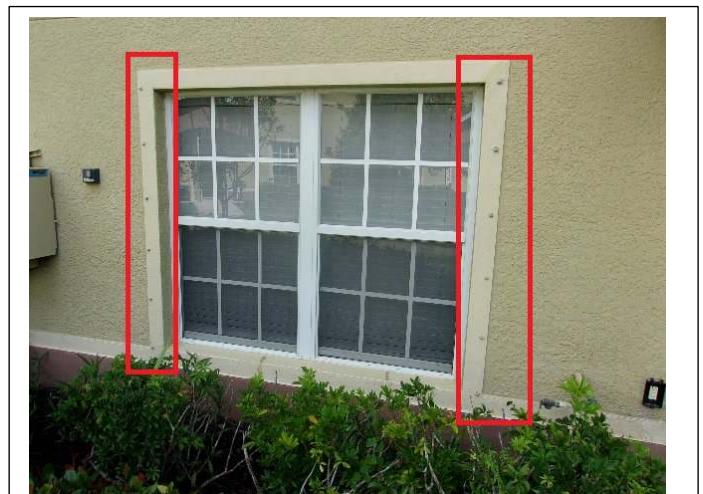
OPENING PROTECTION – Permanent shutter panel mounting hardware is properly installed at ALL window units.

FBC# FL11964.1

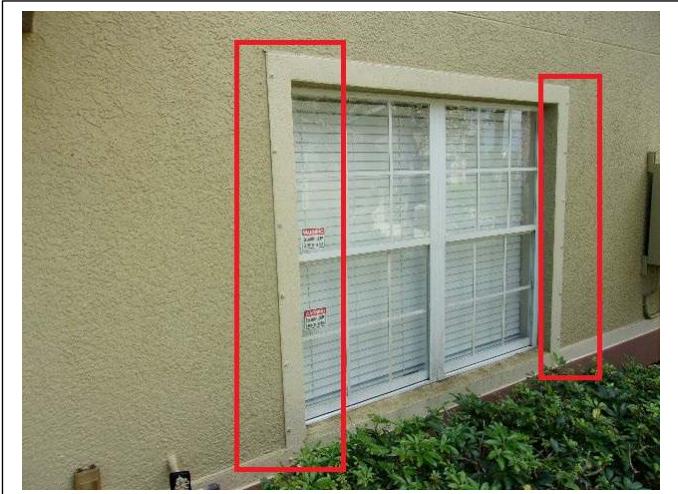
OPENING PROTECTION – Permanent shutter panel mounting hardware is properly installed at ALL window units.

FBC# FL11964.1

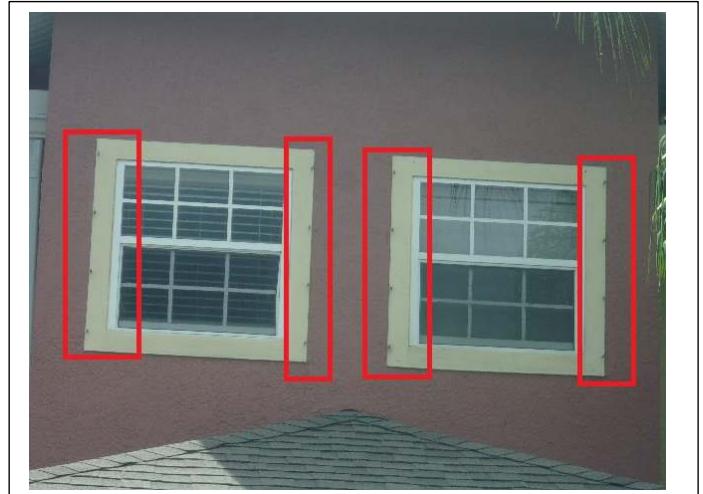
OPENING PROTECTION – Permanent shutter panel mounting hardware is properly installed at ALL window units.

FBC# FL11964.1

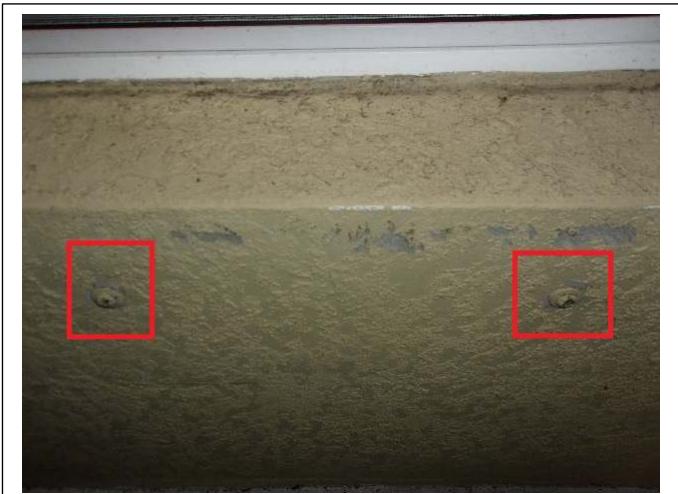
OPENING PROTECTION – Permanent shutter panel mounting hardware is properly installed at ALL window units.

FBC# FL11964.1

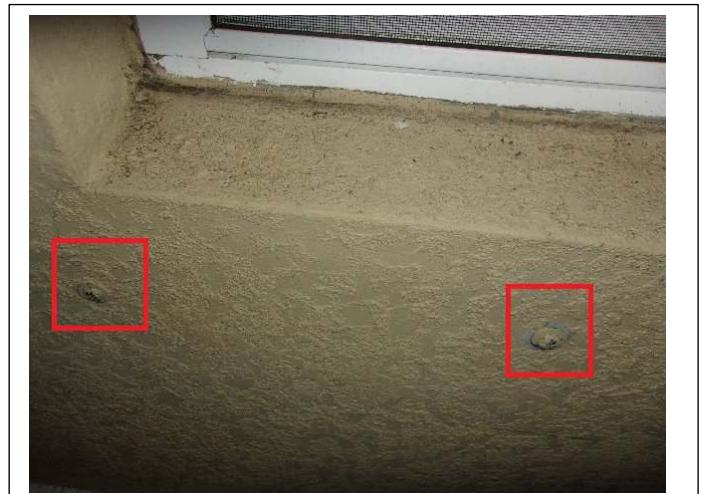
OPENING PROTECTION – Permanent shutter panel mounting hardware is properly installed at ALL window units.

FBC# FL11964.1

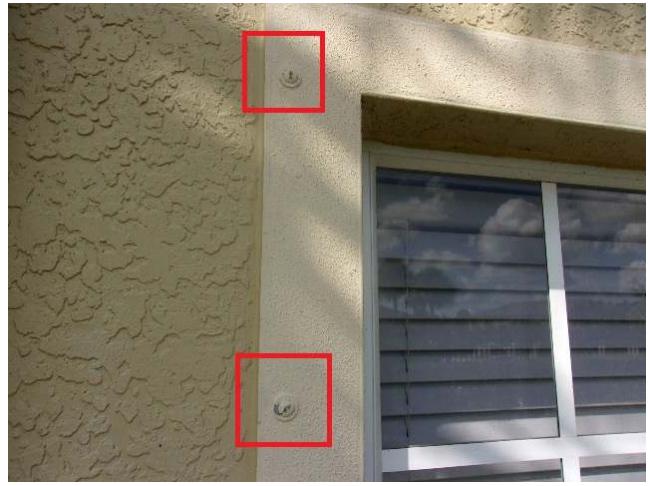
OPENING PROTECTION – Permanent shutter panel mounting hardware is properly installed at ALL window units.

FBC# FL11964.1

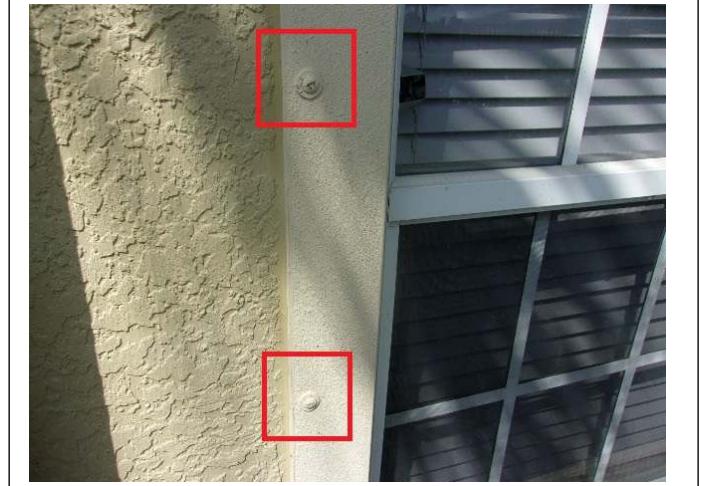
OPENING PROTECTION – Permanent shutter panel mounting hardware is properly installed at ALL window units.

FBC# FL11964.1

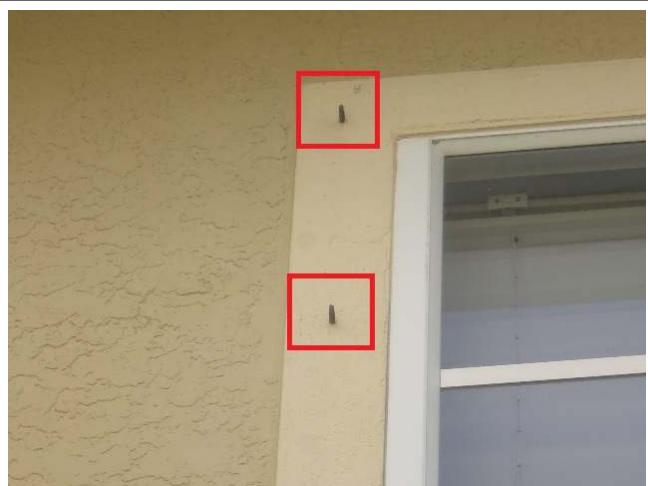
OPENING PROTECTION – Permanent shutter panel mounting hardware is properly installed at ALL window units.

FBC# FL11964.1

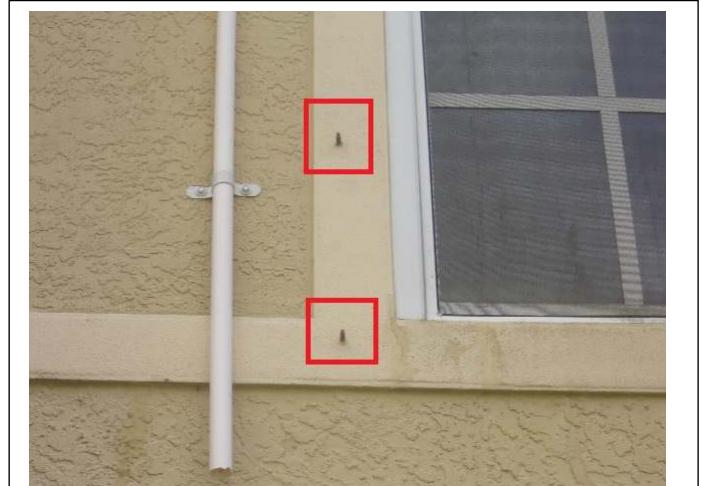
OPENING PROTECTION – Permanent shutter panel mounting hardware is properly installed at ALL window units.

FBC# FL11964.1

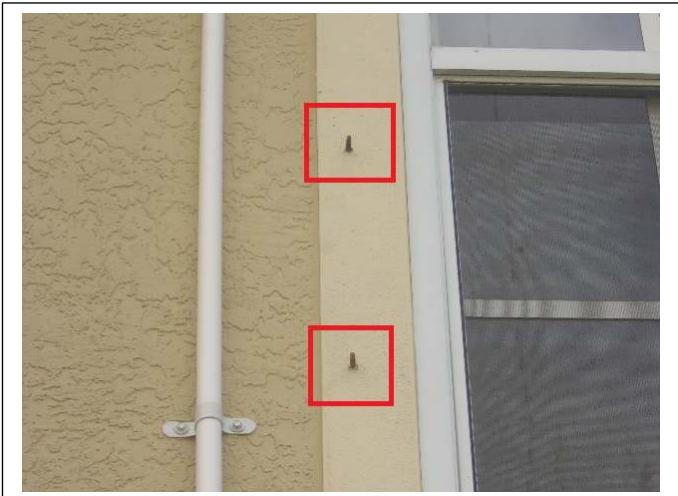
OPENING PROTECTION – The window unit's product approval.
FBC# FL42.2

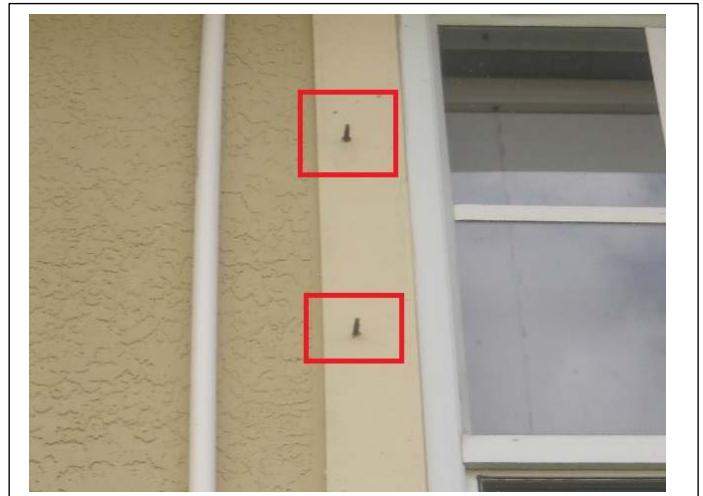
OPENING PROTECTION – The window unit's product approval.
FBC# FL42.2

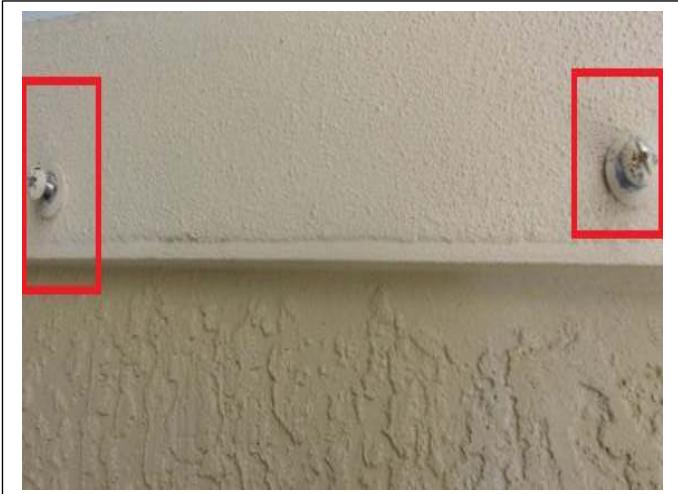
OPENING PROTECTION – Permanent shutter panel mounting hardware is properly installed at ALL sliding glass door units.

FBC# FL11964.1

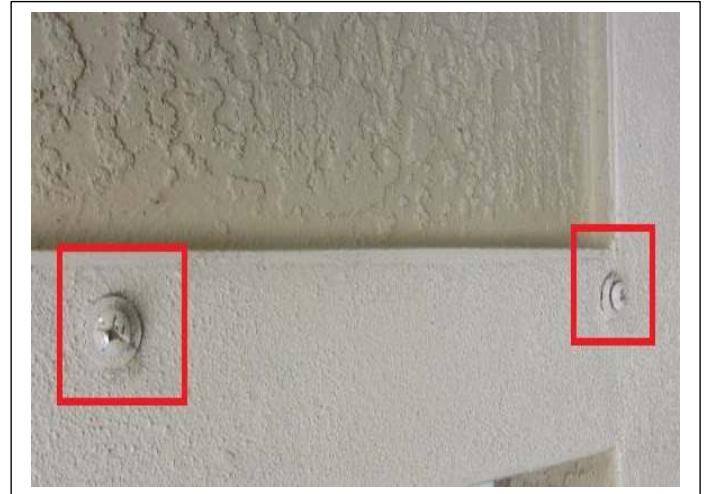
OPENING PROTECTION – Permanent shutter panel mounting hardware is properly installed at ALL sliding glass door units.

FBC# FL11964.1
